HMS *Drake*, Church Bay, Rathlin Island

Undesignated Site Assessment

Ref: 53111.02r-2

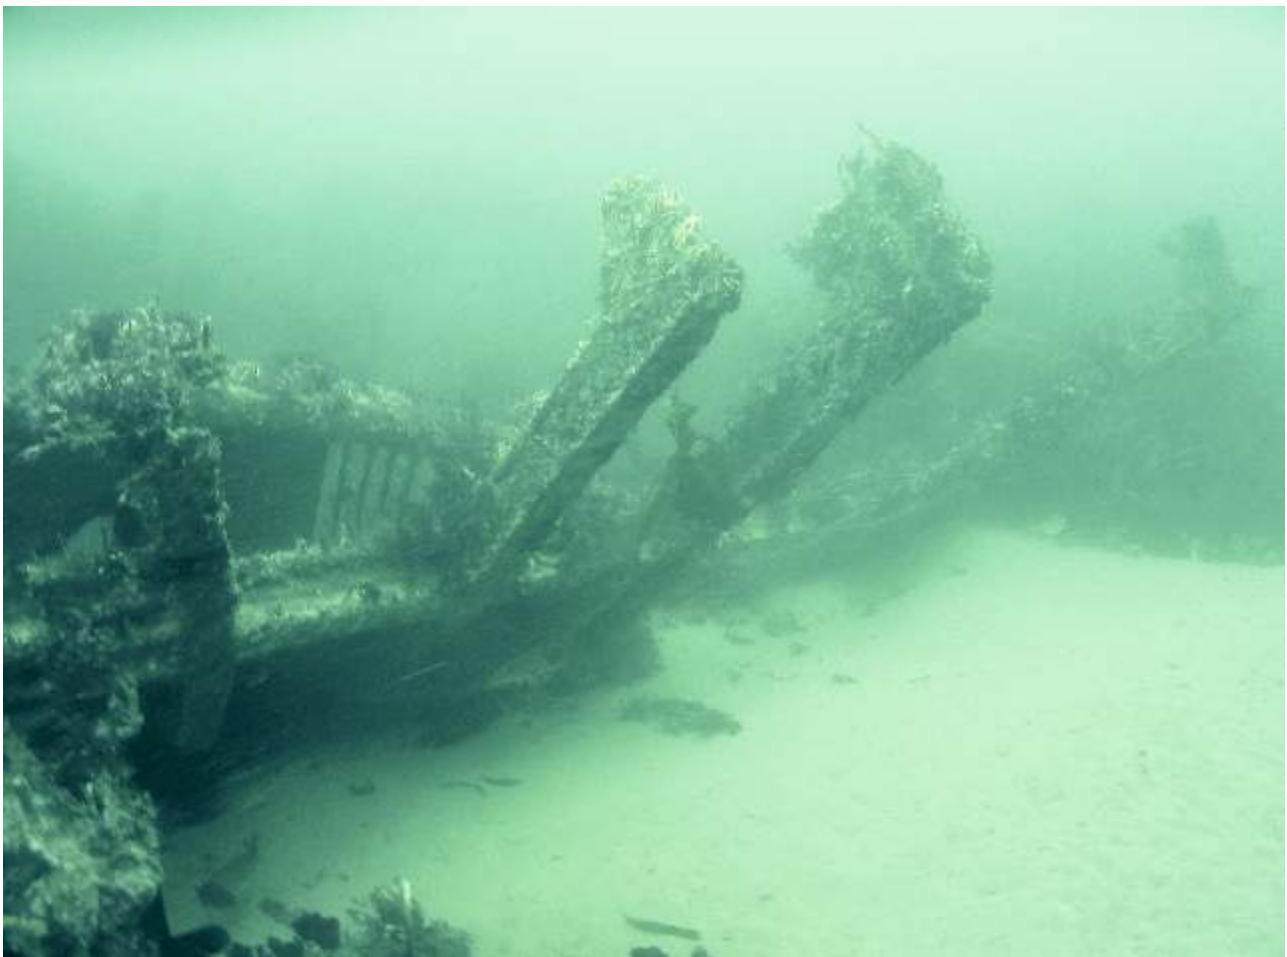
- 5.5.16. Substantial parts of the stern survived as articulated elements of vessel structure (2018), but much of the outer hull plating appeared to be missing (Cover photo). A single hawse hole (2017) with grille features to either side was identified here, which matches with photographs of HMS *Drake* that show a single hawse hole in use on the vessel located centrally at the stern. The hawse hole measured approximately 0.35m in diameter.
