**ARCHAEOLOGICAL SERVICES IN RELATION TO THE PROTECTION OF WRECKS
ACT (1973)**

MINGARY, ARDNAMURCHAN, SOUND OF MULL

DESIGNATED SITE ASSESSMENT: ARCHAEOLOGICAL REPORT

July 2007

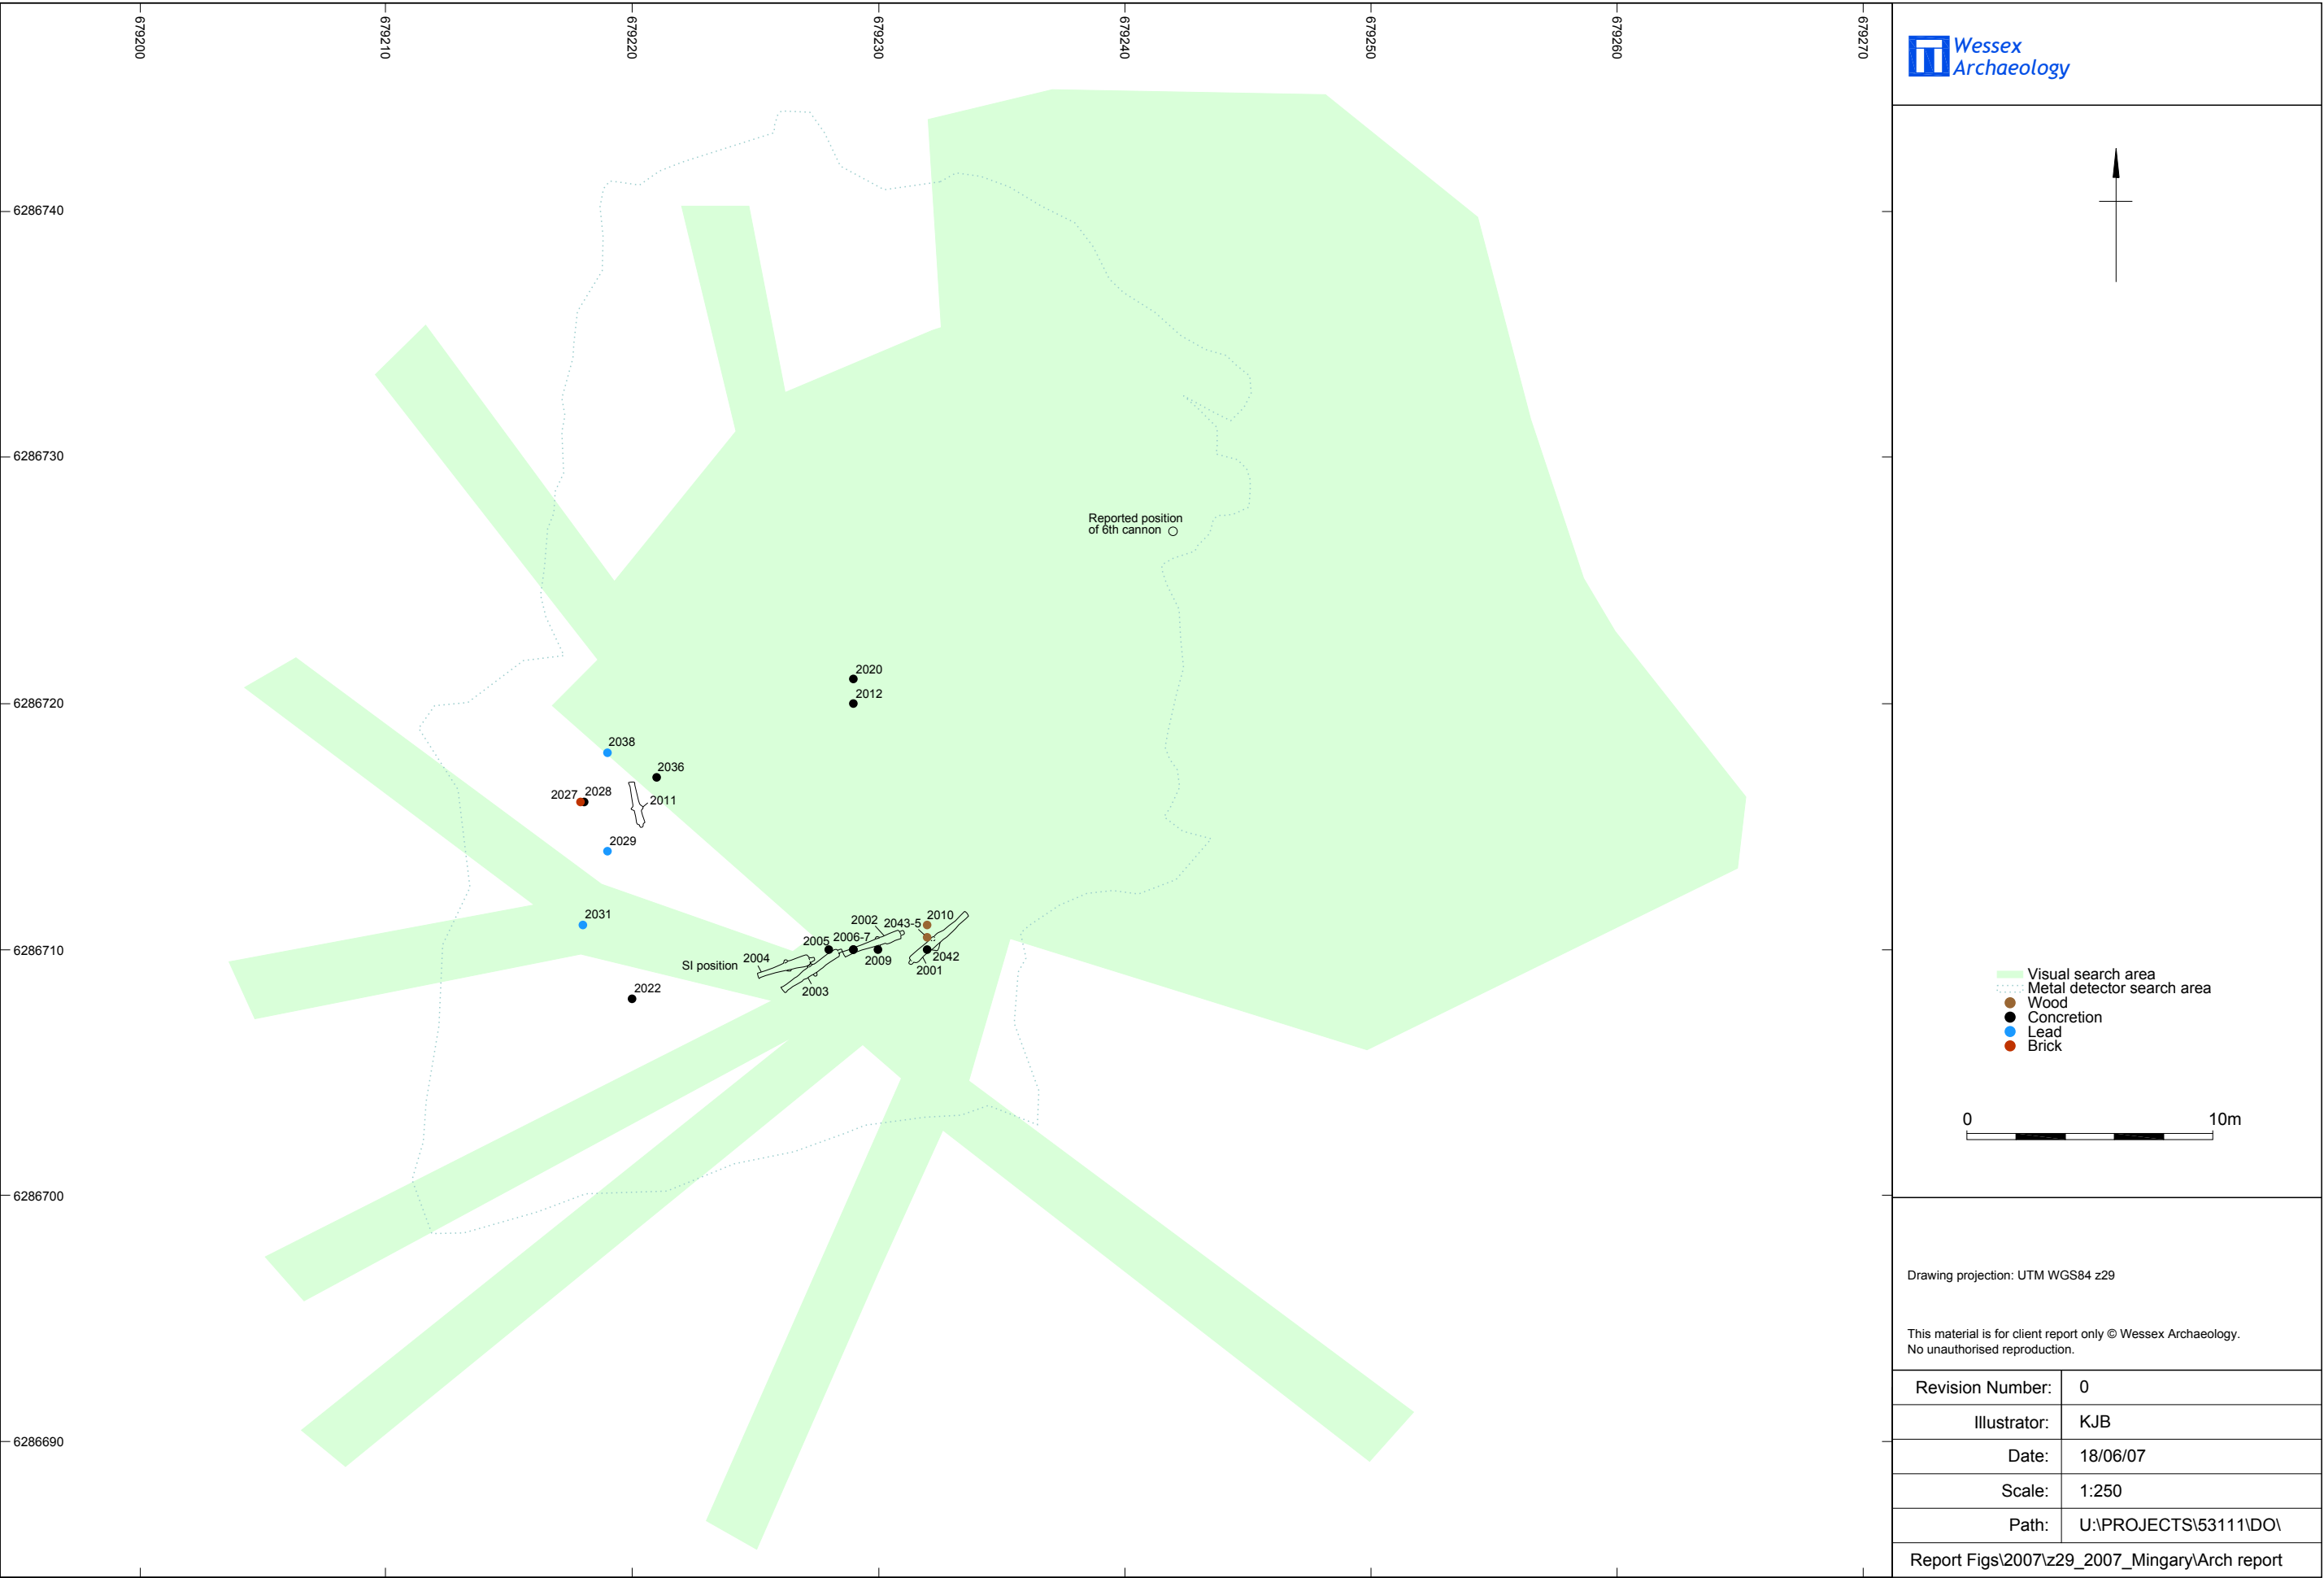
Figure 3

- 3.1.2. Visual searches were conducted in corridors extending outward from the known site to at least 26m in all directions (**Figure 3**). In addition, 100 percent visual search coverage was undertaken in the area to the north-east of the site in an attempt to locate the sixth cannon reported by Steve Barlow. Mr Barlow undertook one dive with the WA team in an attempt to locate the cannon. Despite his assistance and the intensive searches undertaken by the team the cannon was not located. The position of the cannon as reported by Mr Barlow can be seen in **Figure 2**.

Visual seach area

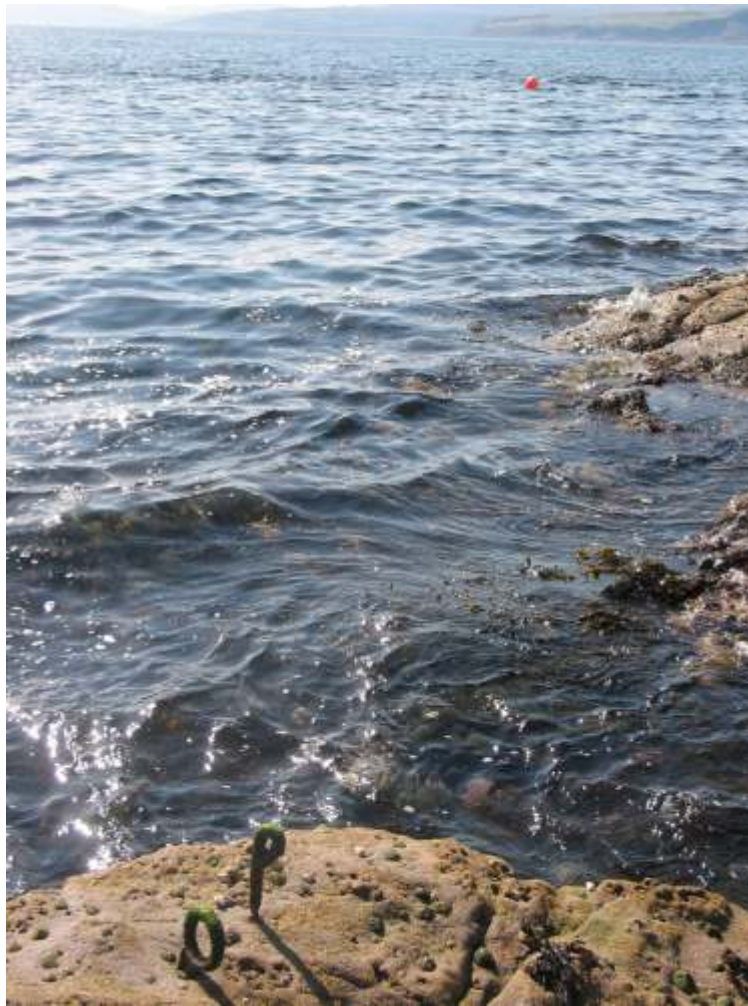
- 3.2.1. A walk-over assessment of the shore adjacent to the site was carried out at low tide. A visual inspection and targeted metal detector searches were conducted on the small rock outcrop that points towards the site at low water. Nothing was identified through metal detecting but two modern pins were located on the furthest extremity of the outcrop; these may be related to fishing activity but did not look as though they had been in use recently. The pins' position in relation to the site, which is marked by an orange buoy, can be seen in **Plate 1**.

Plate 1. Pins in rock with view of site

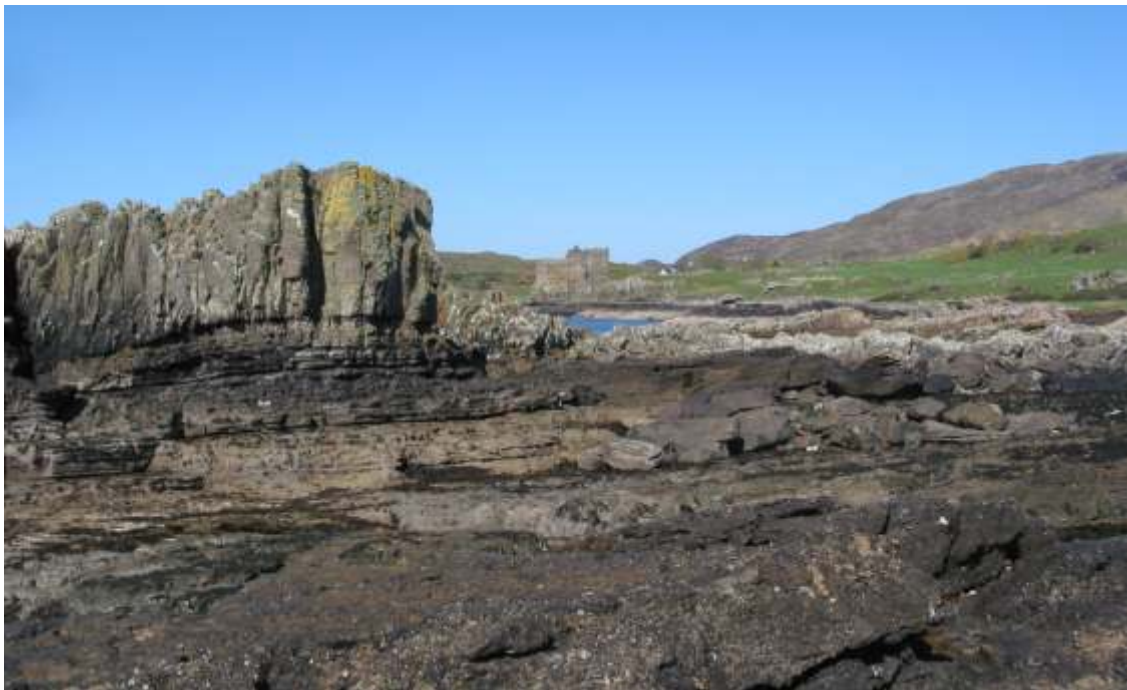
Plate 2. View of Mingary castle from the rocky outcrop at the site

- 3.2.2. A theory that was first suggested during the Wreck Detectives program was also investigated by WA. It was suggested that the vessel was sheltering from enemy fire behind the rocky outcrop whilst unloading cannons to be used against the castle. This can be seen in the cover shot of the site, taken from the ground floor of the castle (note: an even better view would have been possible from the top of the castle wall), and looking from the behind the rock at low tide to the castle in **Plate 2**.

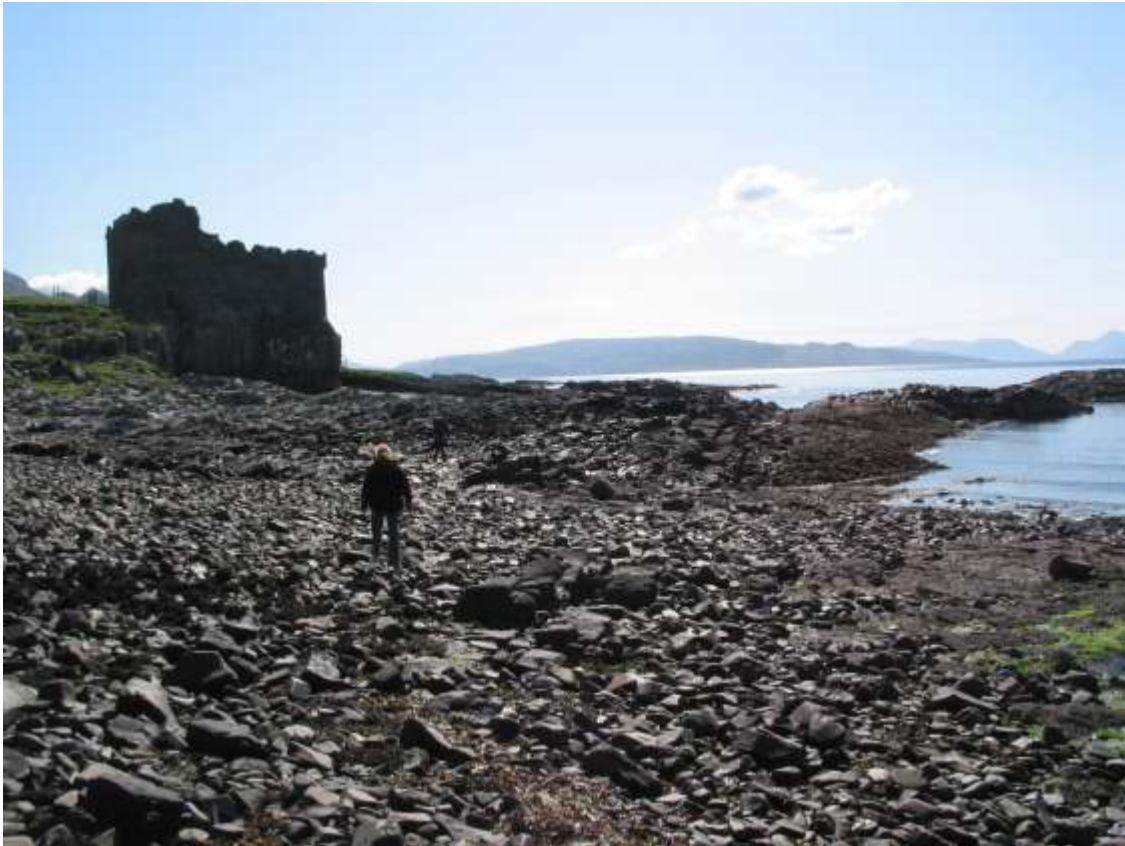
Plate 3. Looking to Mingary Castle in the east from the original location of the cannon, now outside Mingary Castle

- 3.2.4. Discussions with Donald Houston, owner of Mingary Castle and the surrounding land, identified the location of a cannon that was reported by Steve Barlow to have been seen on the beach below the castle. Mr Houston attested to the fact that the cannon had lain on the beach just to the west of the castle for a number of years in the area shown in **Plate 3**. Approximately three years ago Mr Houston moved the cannon to its current position, outside the inland entrance to the castle, as a result of rumours that it was going to be taken by locals.

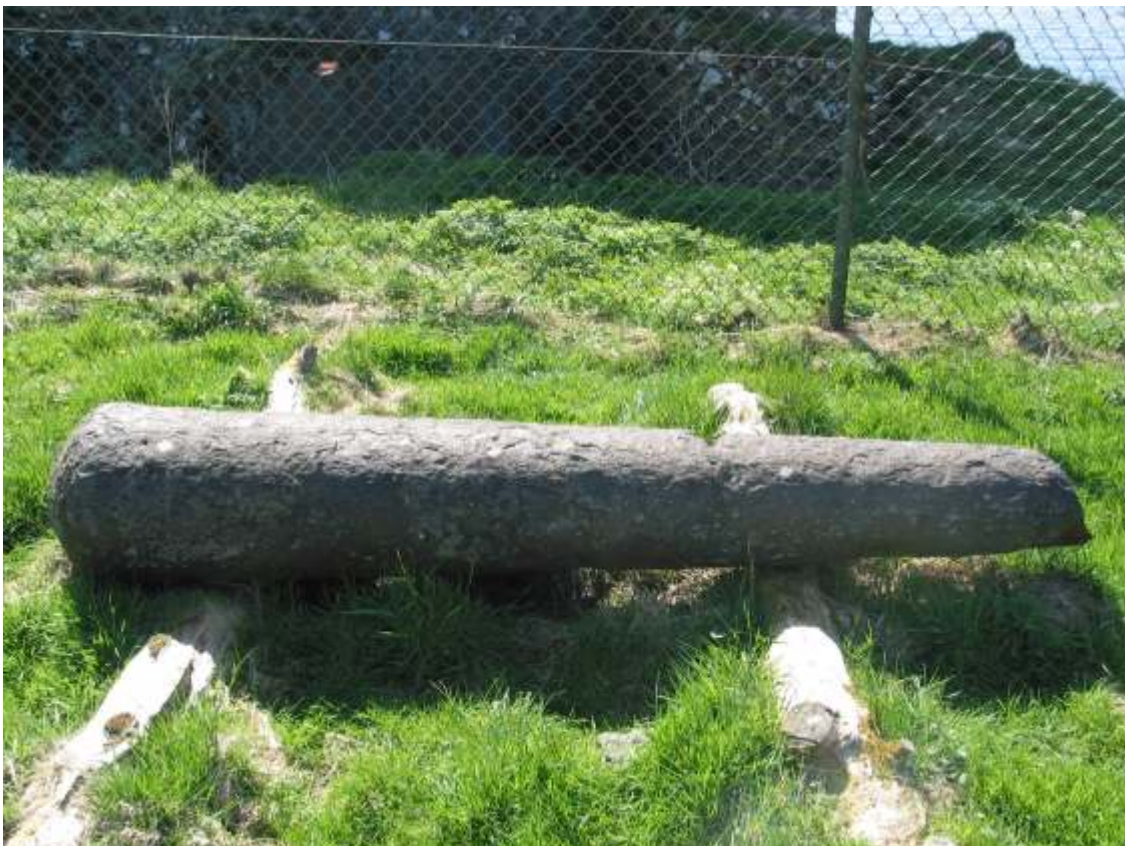
- 3.2.5. The cannon is a cast iron muzzle loader, approximately 1.8m long (**Plate 4**). It is badly corroded; the tip of the muzzle has broken off and the cascabel is missing its button. The only visible features are the touch hole and a square indent possibly indicating the original position of a trunnion. There is no evidence to suggest that this cannon is linked to the wreck site; it was found over 600m away and is smaller than the other cannons. It could equally be related to the Spanish attack in 1588, or be a piece of ordnance the originated from within the castle itself.

Plate 4. Cannon outside Mingary castle

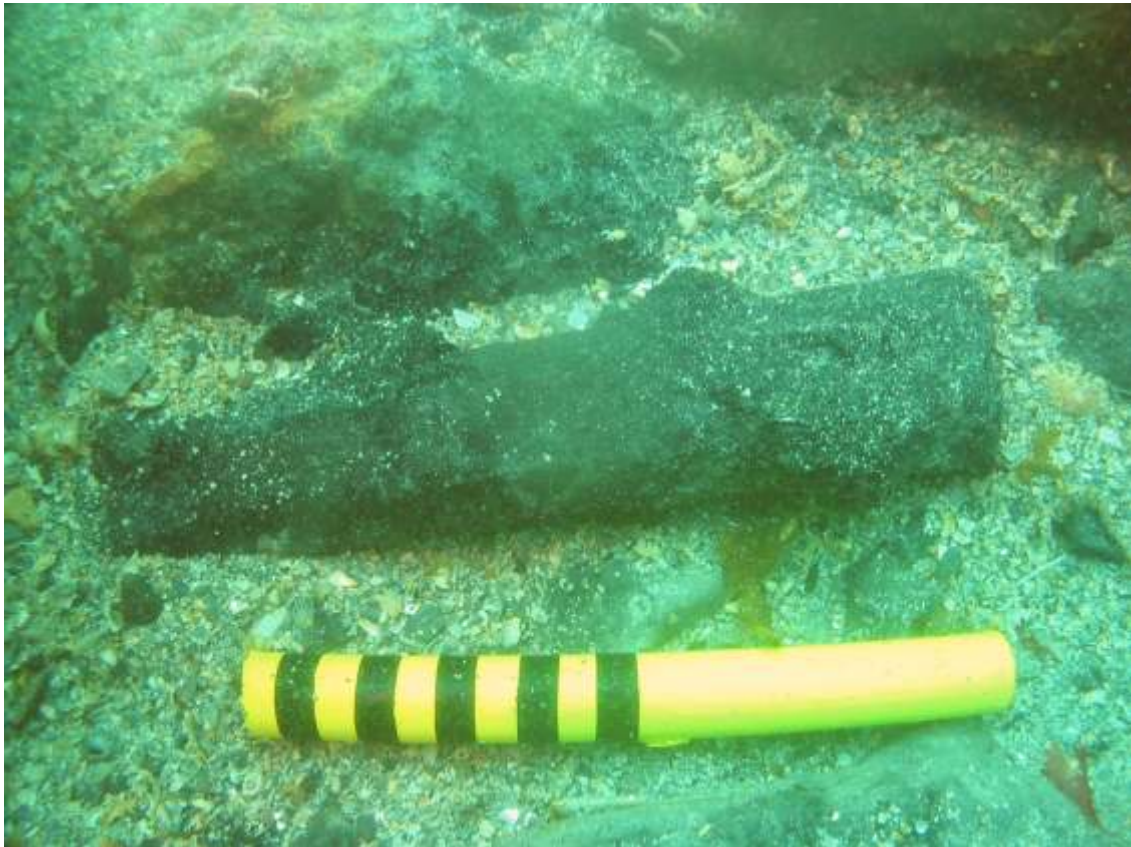
- 3.4.1. Three new artefacts were located in 2007; all three were found lying partially underneath cannon **2001** within silty-sand **4002**. This suggests that there may be more artefacts, as yet undiscovered, within this area. Artefact **2043** (**Plate 5**) is an almost cylindrical piece of wood that tapers slightly to one end, possibly a wedge (Mark Laurence pers. comm.). Timbers **2044** (**Plate 6**) and **2045** may be pieces of planking, however very little of the wood was exposed making identification difficult. All three pieces of timber are likely to be those initially identified by Phil

Plate 5. Timber 2043

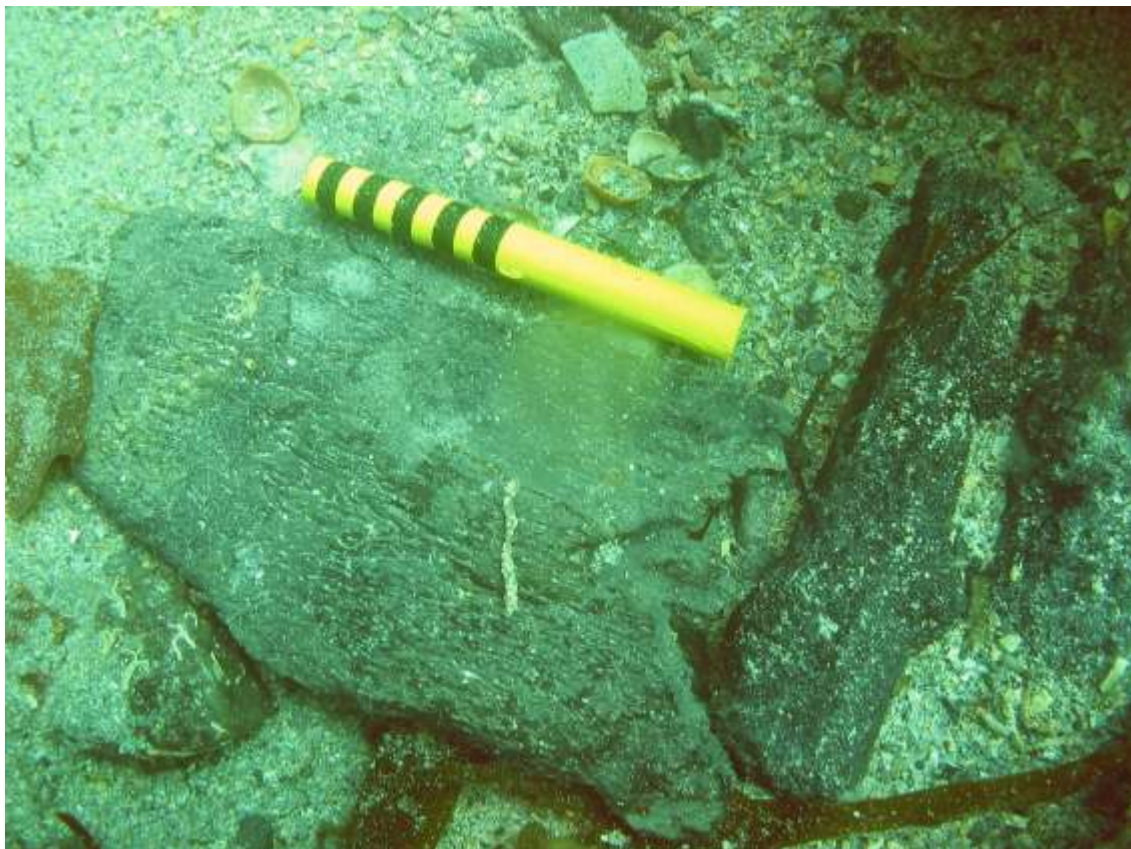
Plate 6. Timber 2044
