# *Sainte Apolline's Chapel St. Saviour's, Guernsey*

## *Conservation Plan*

*Ref: 53511.03*

*December 2003*

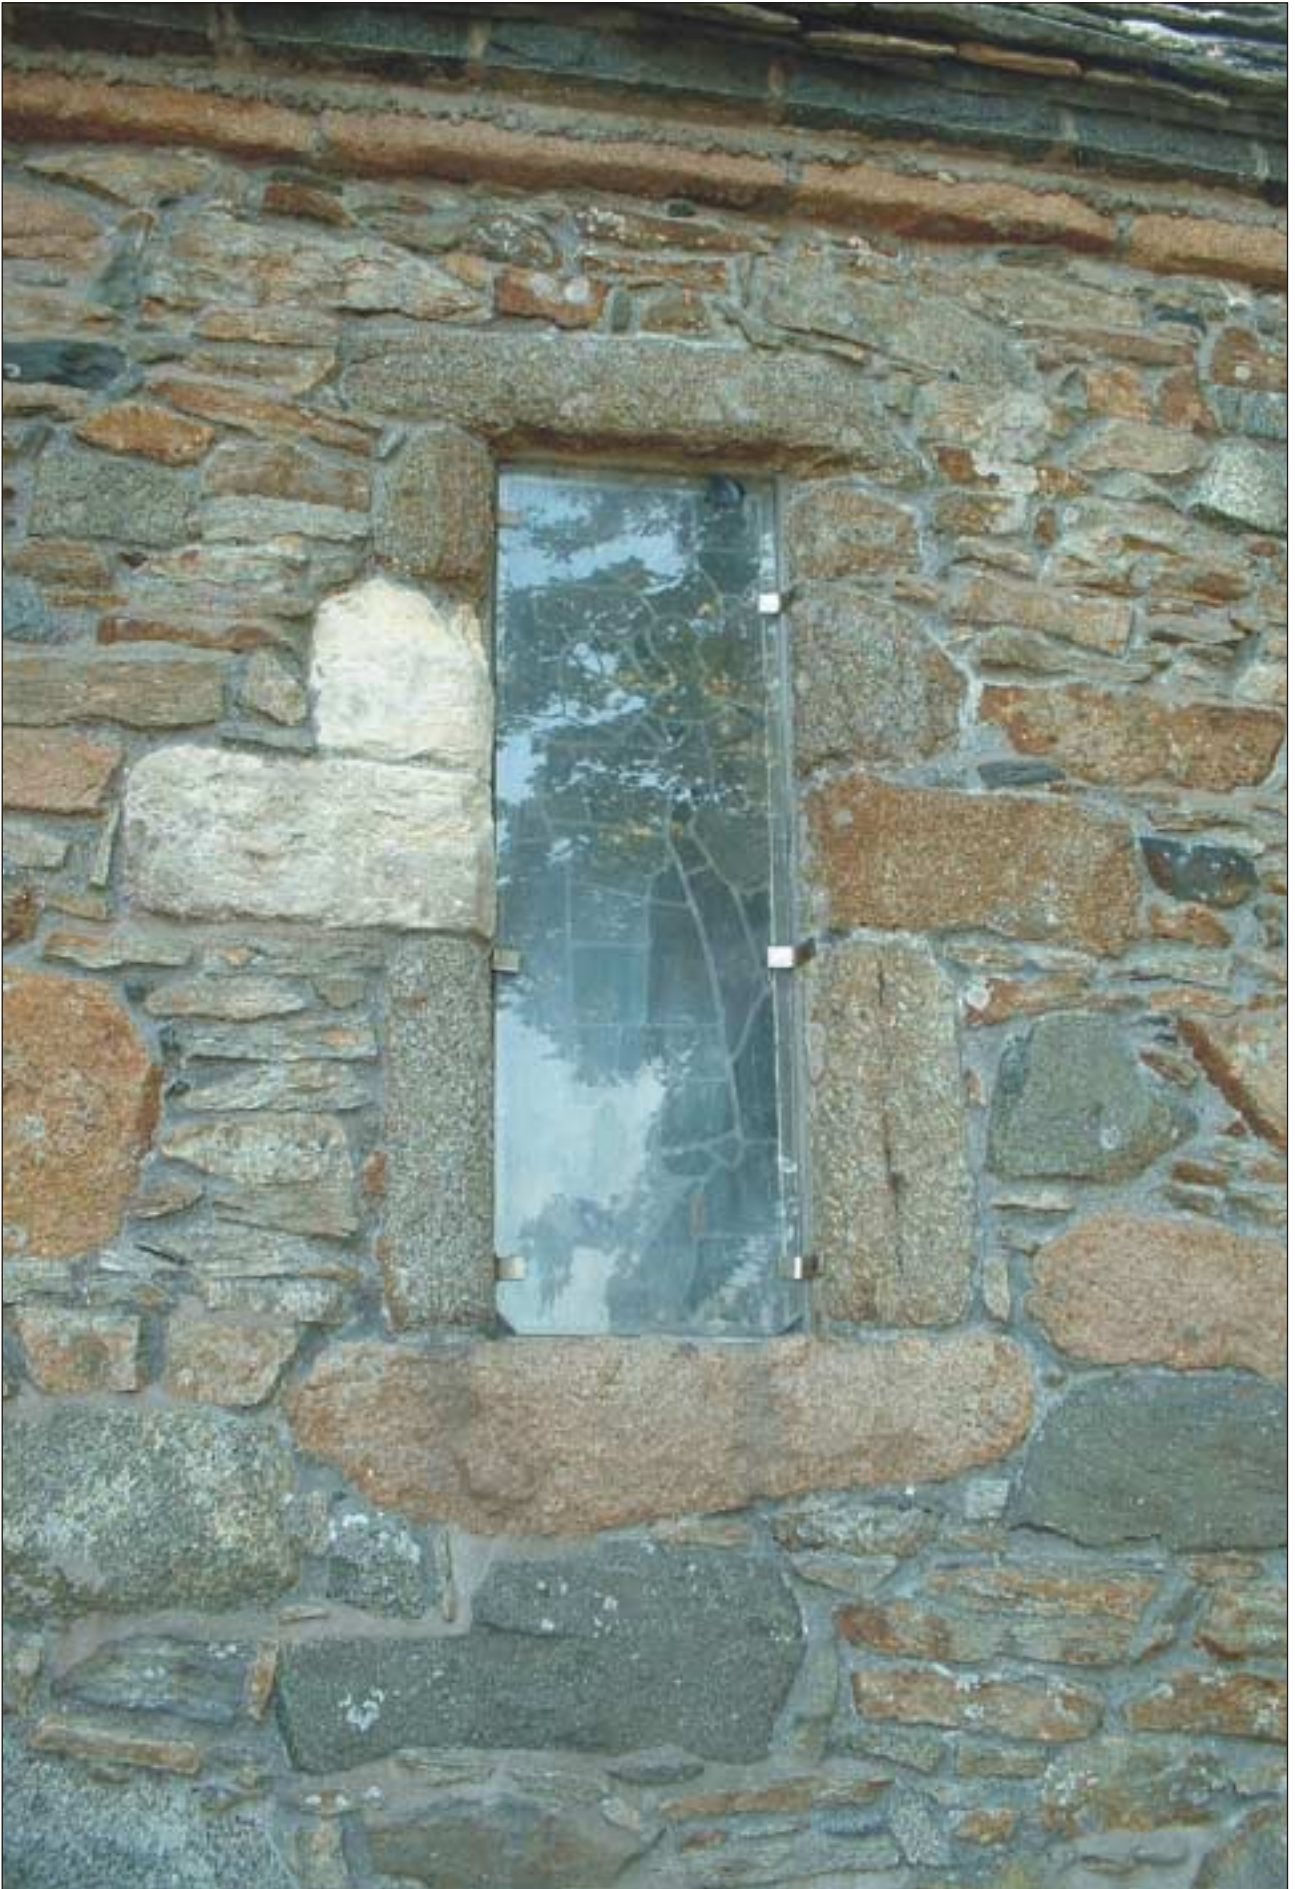
Caen stone blocks in the jamb of the north window.

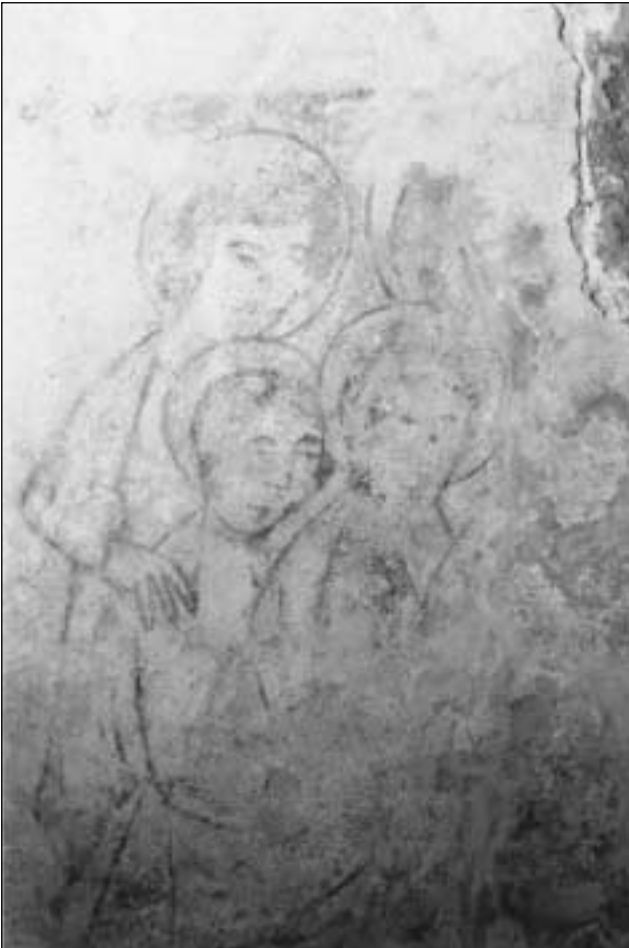
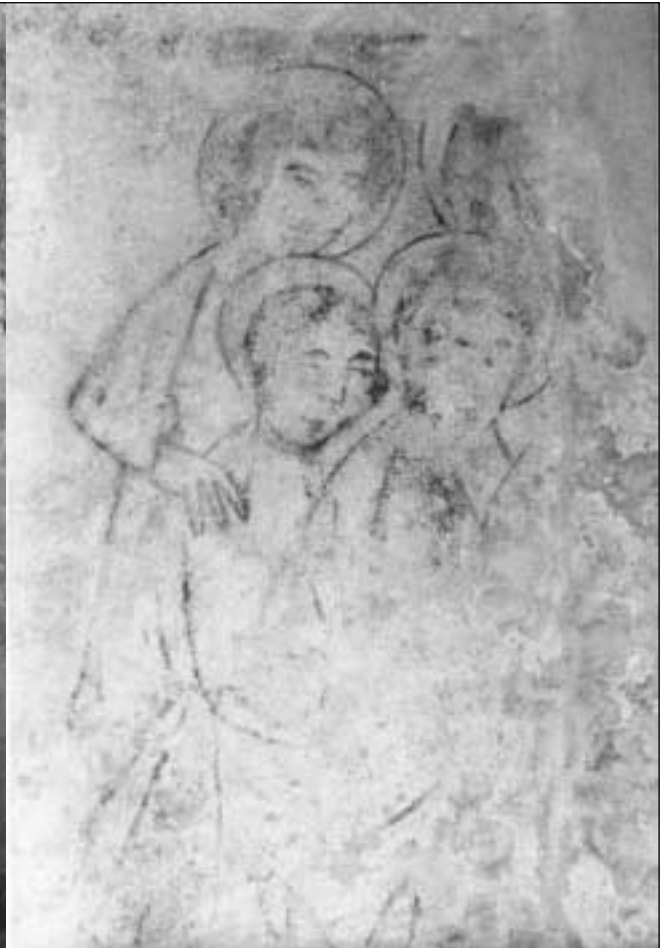
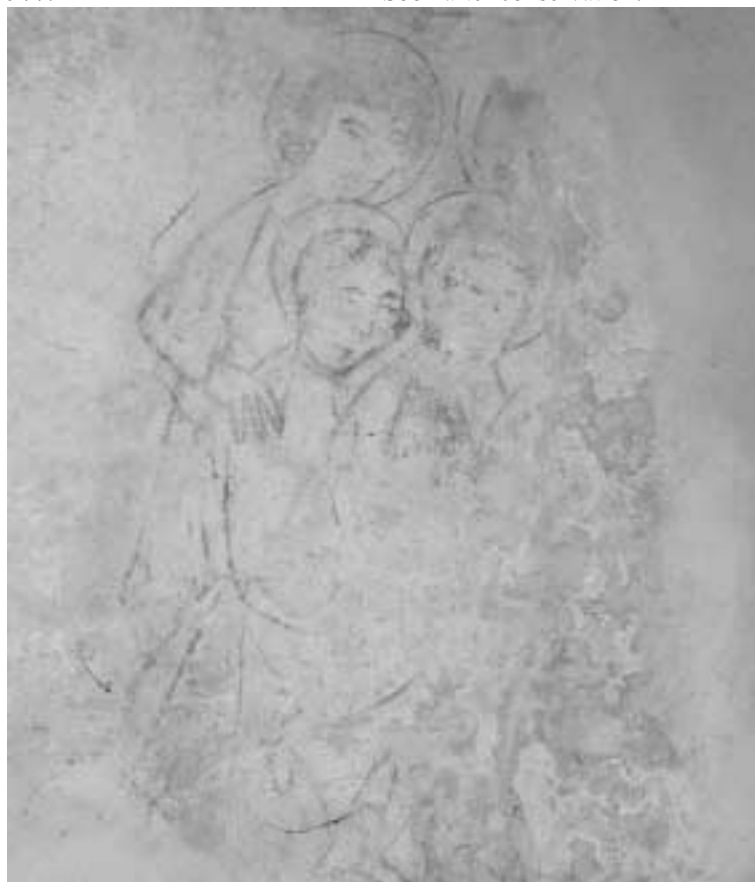
Comparison of photographs of wall paintings.

most clear, along with the yellow hair colouring of some of the figures and a dark blue colour visible on two of the central figures. It is not clear whether this is pigment or discolouration, possibly as a result of past mould growth. Originally other pigments would have been applied over the red underpainting once the plaster was dry, although these are now lost, possibly due to fading or through flaking from the surface as a result of the unstable conditions in the Chapel.

The paintings are situated above the level of rising damp which is disrupting the newer plaster at a lower level. The surface of the paintings was inspected using a magnifying glass and a torch. Additional lighting was provided to ease the viewing. On close inspection there was some evidence of paint loss in small areas. This is likely to have occurred as a result of the mobilisation and crystallisation of soluble salts by the fluctuating humidity levels within the Chapel. It has been reported by visitors to the Chapel that at times areas of salt crystals are visible on the south wall. There is a slight surface 'bloom' as a result of the salt movement, which could account for references to the paintings fading over the years. At the time of the visit, the paint surface appeared sound with the plaster well adhered to the substrate. At the junction of the medieval and the new plaster, there are signs that some areas of painting have been covered by the application of new plaster. There is no sign of active mould growth; however the environment is far from ideal and the paintings are

at risk from the unstable conditions within the Chapel. The paintings and the upper regions of the vault are covered with a layer of dirt and cobwebs.

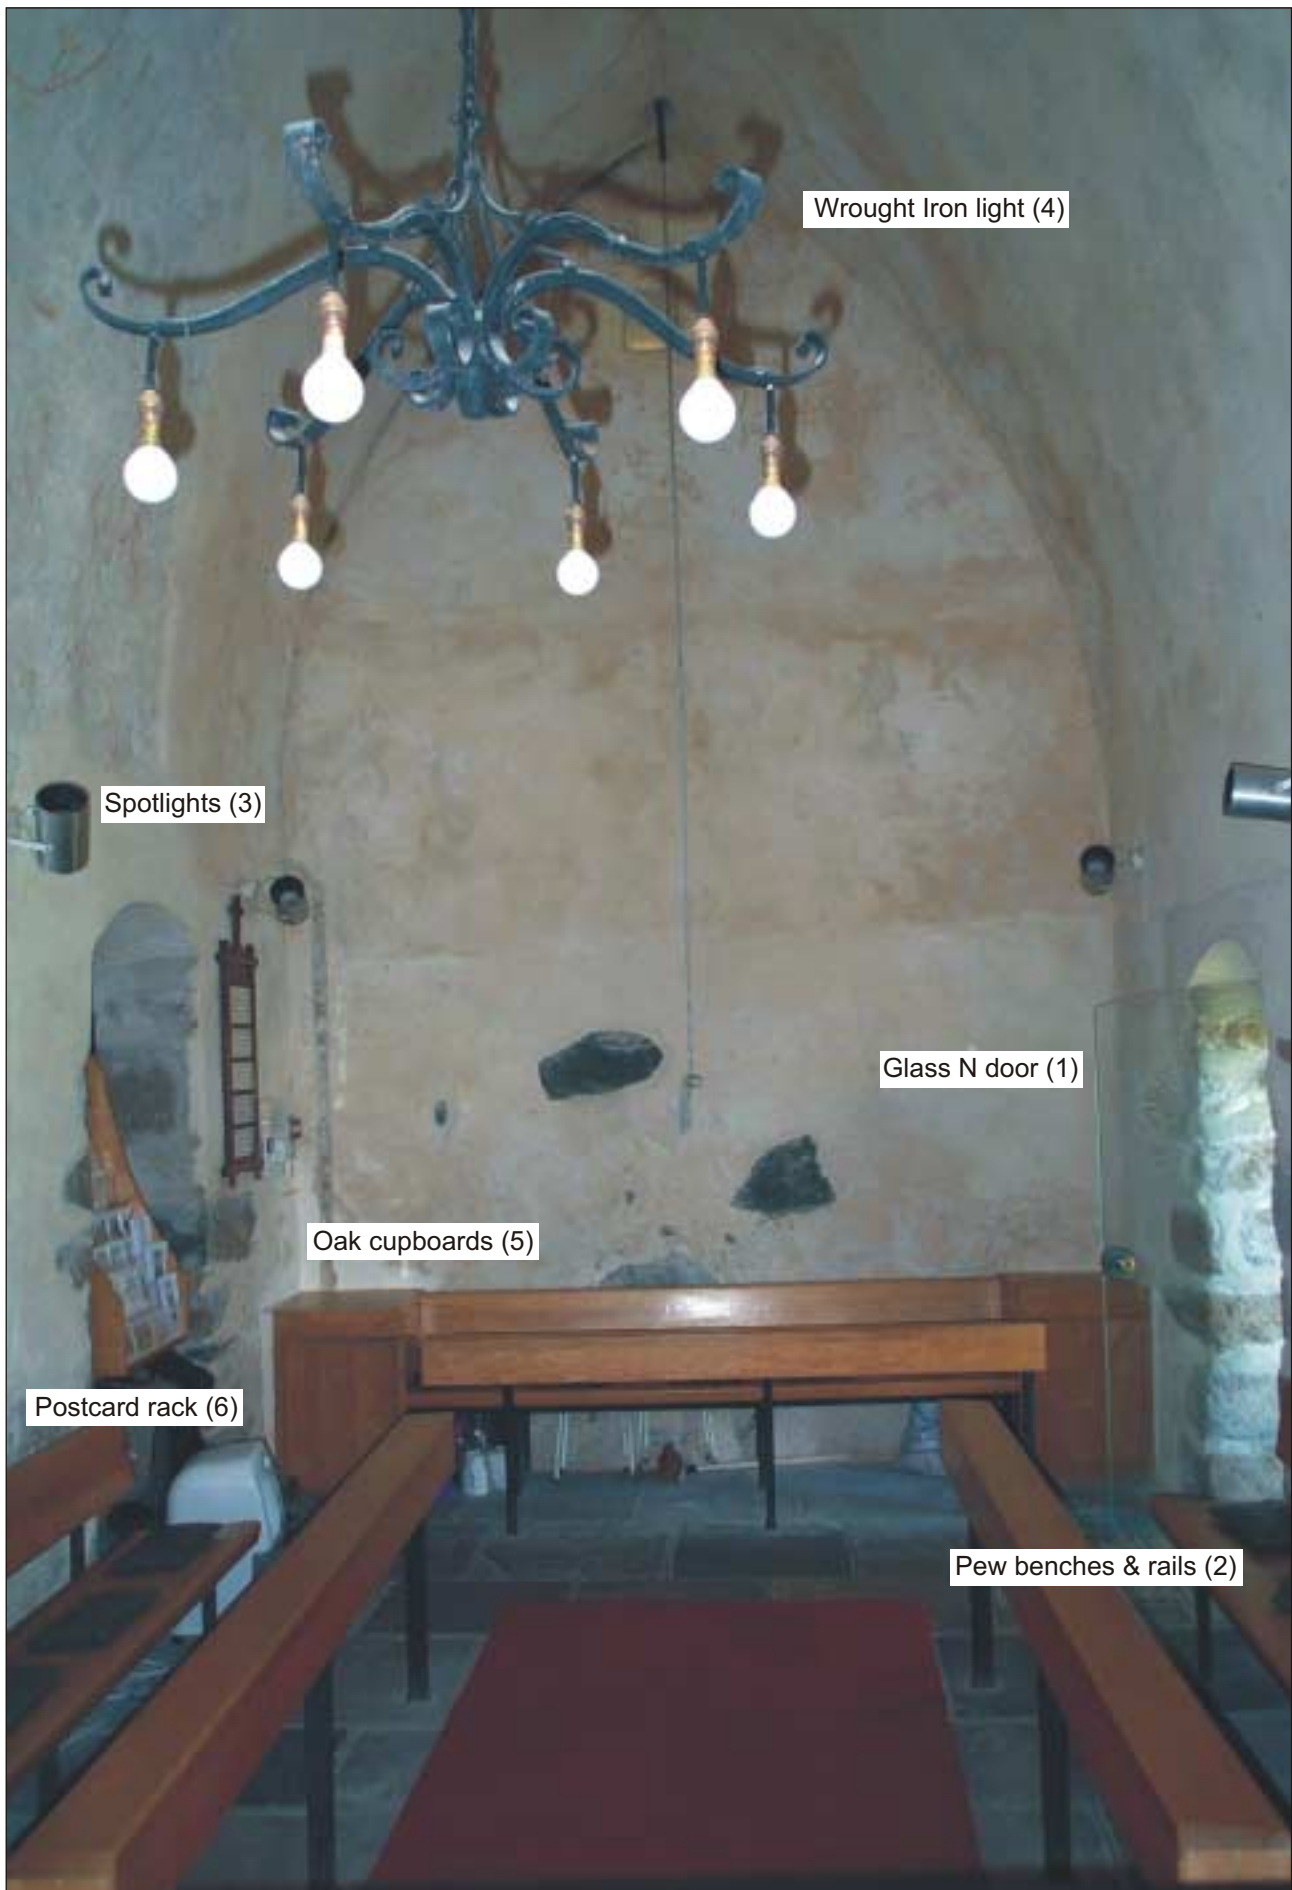
Gazetteer components 1-6.

<b>No. 3</b>	<b>Spotlights</b>
<b>Date &amp; source</b>	1973-8 (Brandt Potter Hare Drwg no. 3075/1A: 5 <sup>th</sup> March 1973).
<b>Description</b>	Four aluminium spotlights on south wall and four on north wall, each with a 75 watt bulb
<b>Historic significance</b>	Negative - Part of the 1970's restoration <u>but</u> possibly causing heat damage to paintings and wiring has been chased into C14 plaster.
<b>Appearance</b>	Negative - unsympathetic to historic character of Chapel, and wiring, which has been chased into C14 plaster looks unsightly
<b>Issues</b>	Light should not be placed so close to wall paintings
<b>Policies</b>	Wall plaster must not be further removed or damaged. Consider replacing with up-lighters as in Fisherman's Chapel, Jersey.

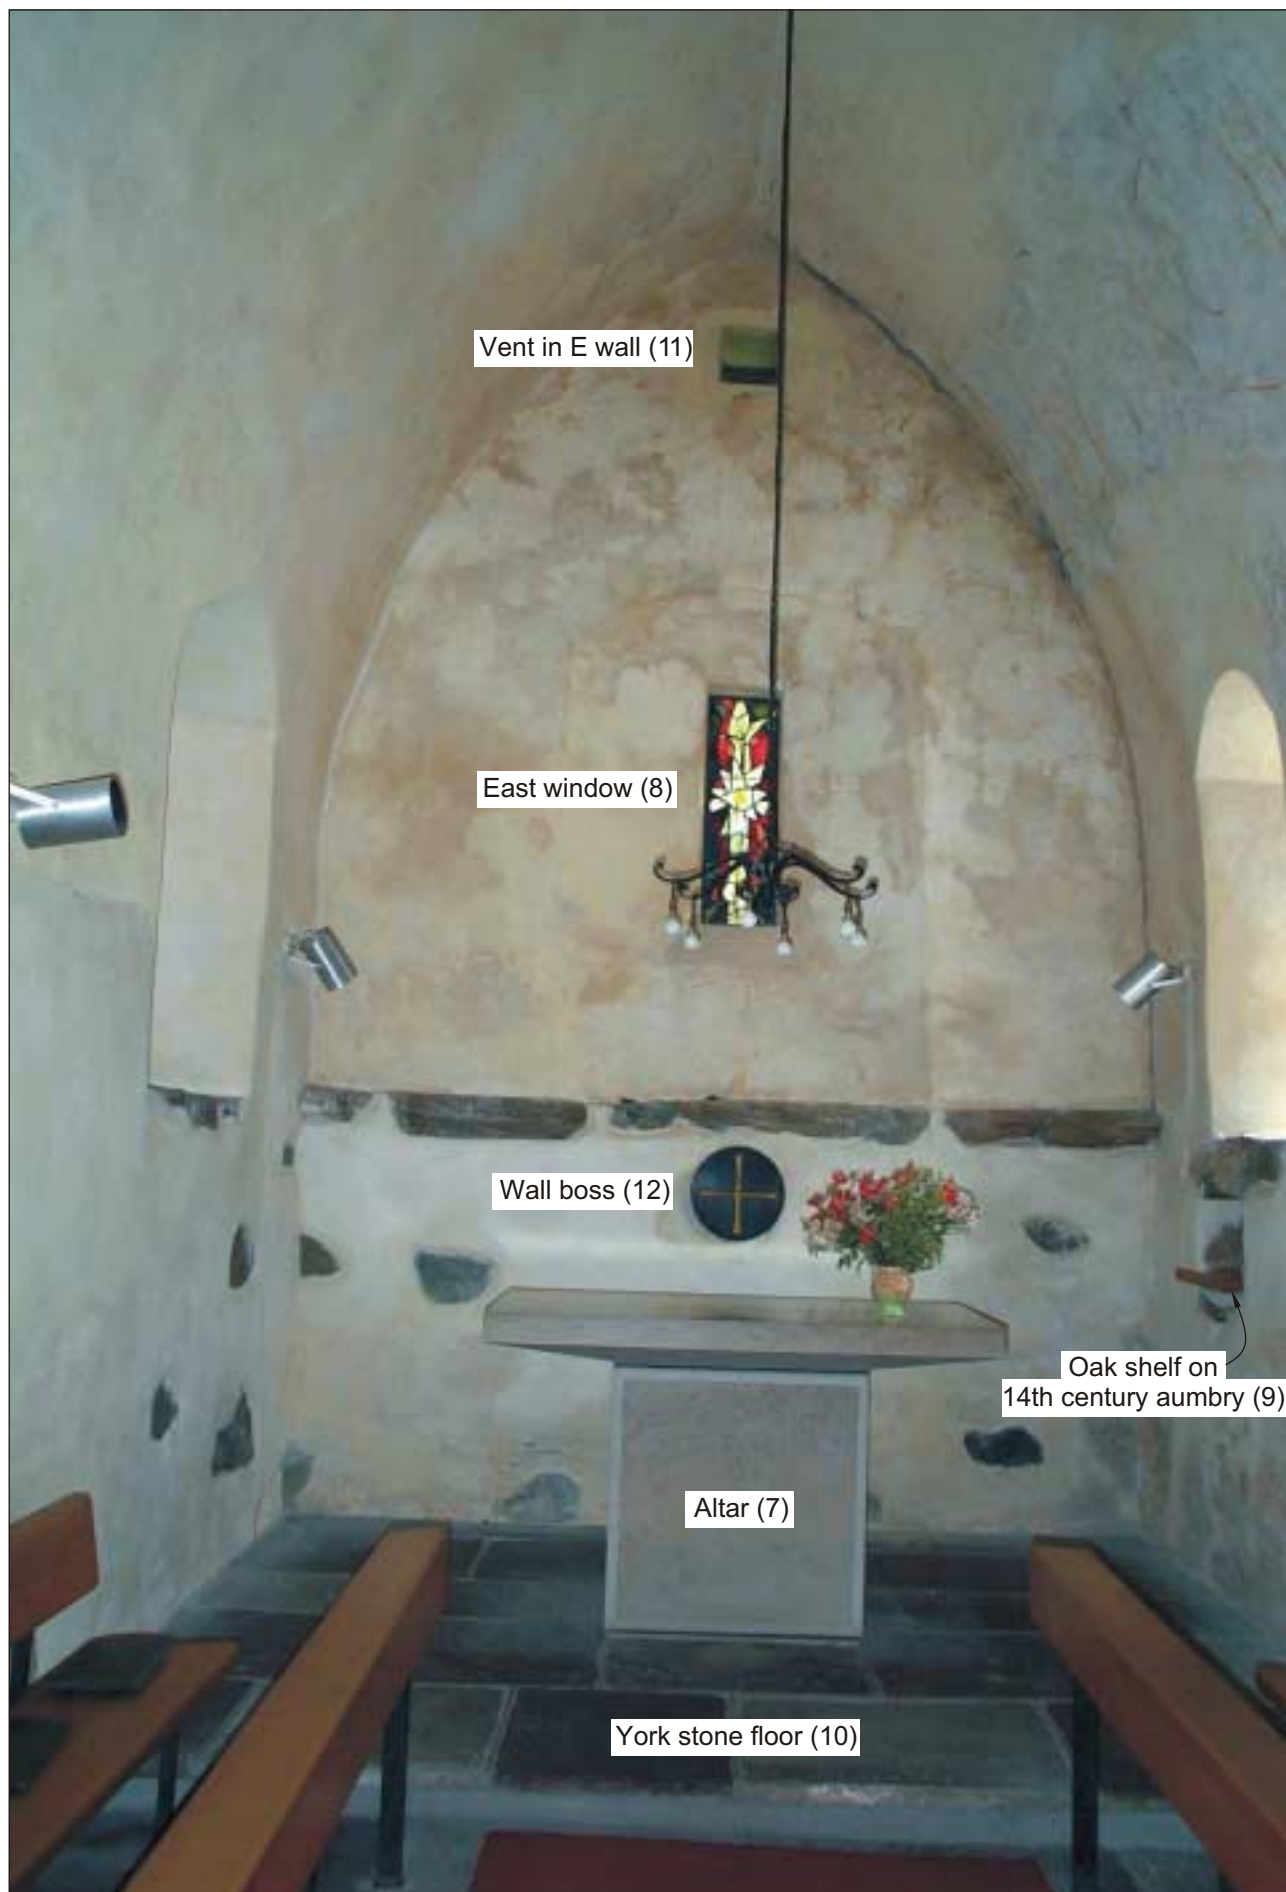
Gazetteer components 7-12.

<b>No. 7</b>	<b>Altar</b>
<b>Date &amp; source</b>	1973-8 (Brandt Potter Hare Drwg no. 3075/6A: 5 <sup>th</sup> March 1973).
<b>Description</b>	Polished Purbeck Marble altar by W. J.Haysom and Son, Dorset
<b>Historic significance</b>	Neutral – Part of the 1970's restoration.
<b>Appearance</b>	Negative - uncompromisingly modern altar, sharp lines and smoothness contrast with Chapel stonework. Altar is too big for size of Chapel.
<b>Issues</b>	The existing altar is of its time, but overpowers the simple interior of the Chapel
<b>Policies</b>	Replace with a smaller simpler altar.

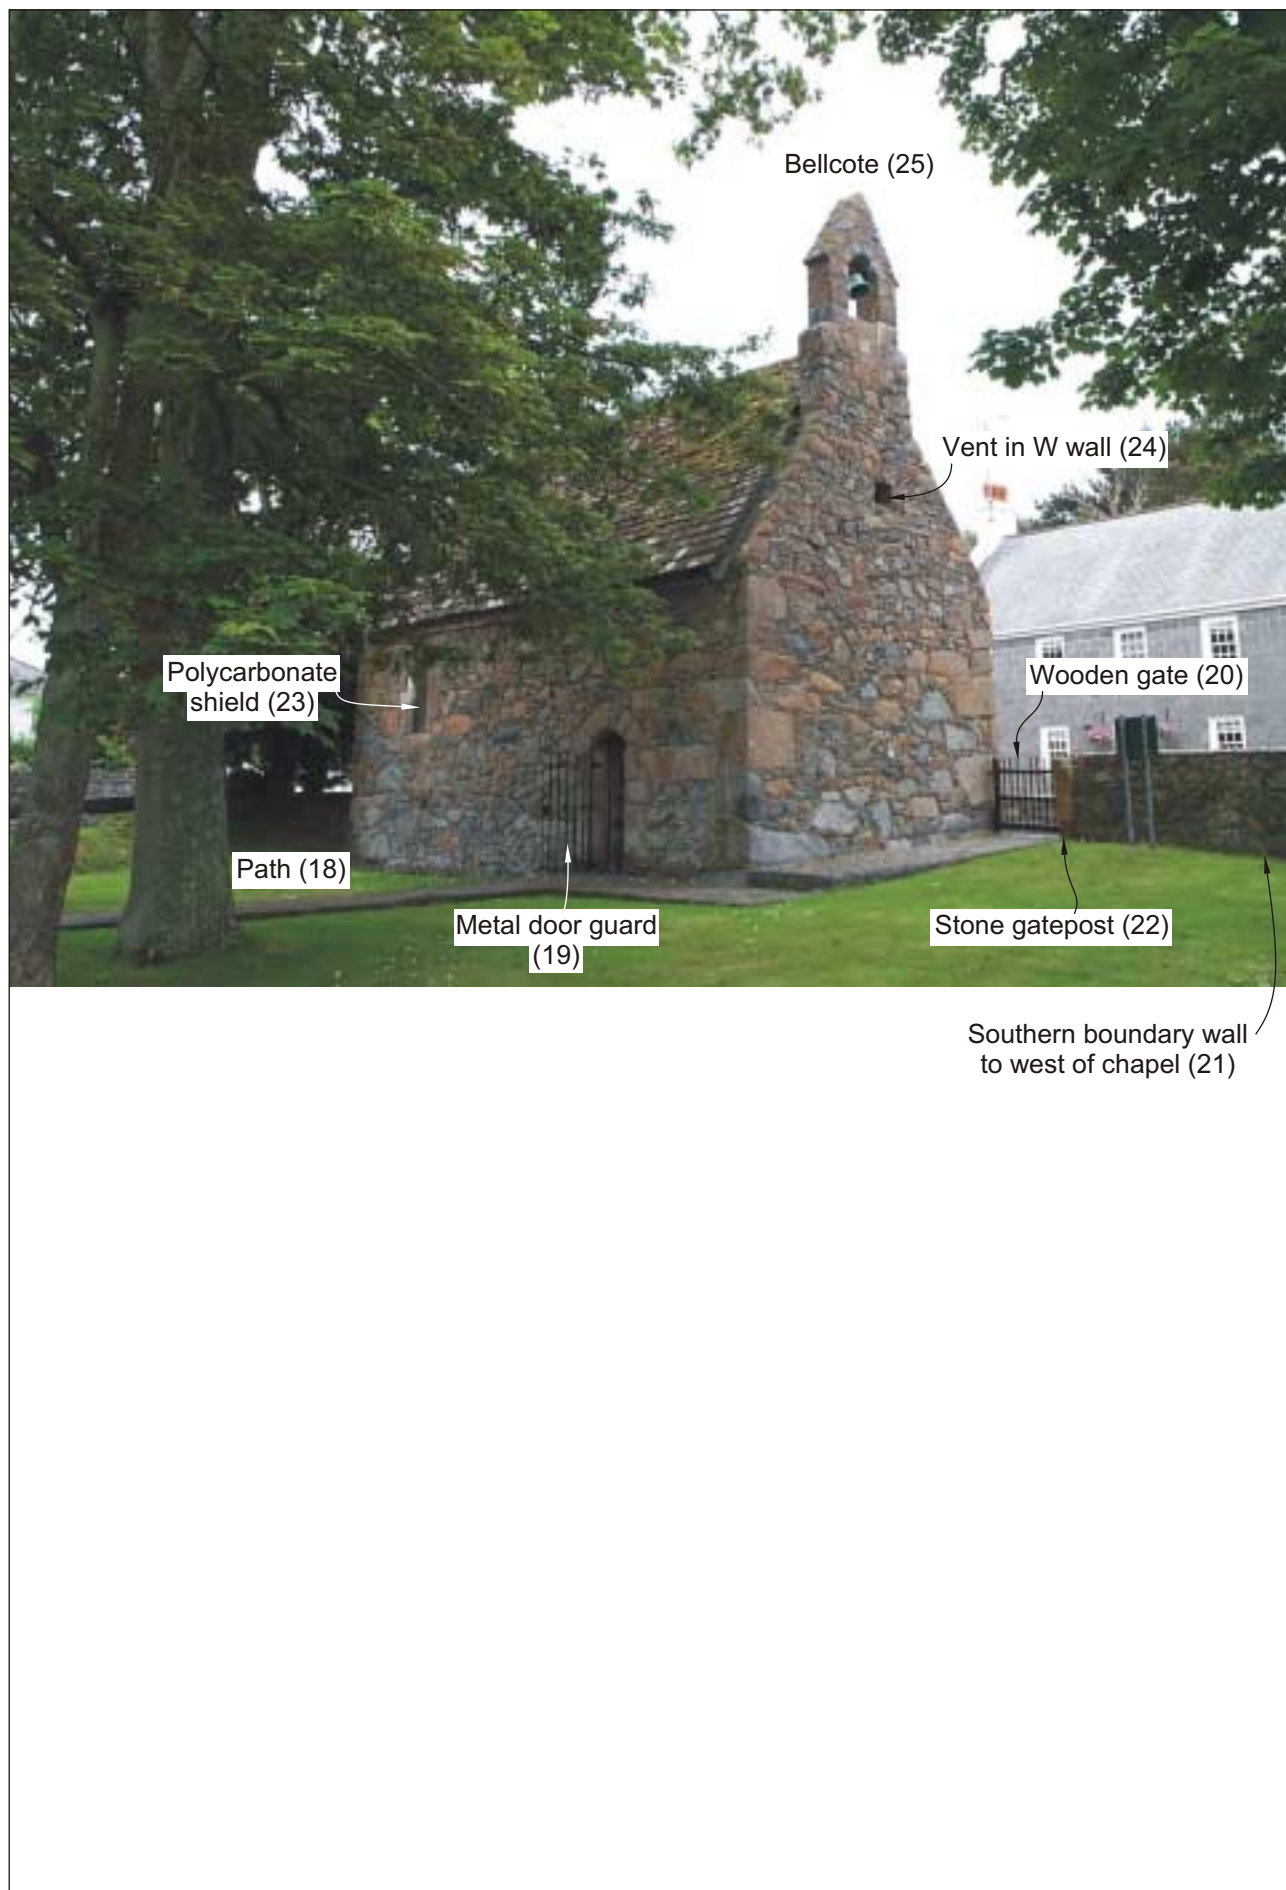
Gazetteer components 18-25.

<b>No 25</b>	<b>Bellcote</b>
<b>Date &amp; source</b>	Base original, rest probably removed during C16 Reformation. Rebuilt 1973-8 (Brandt Potter Hare Drwg no. 3075/10: 19 <sup>th</sup> April 1972).
<b>Description</b>	Granite stonework noticeably different to rest of Chapel. Hard cement mortar, joints not cut back as much as original Chapel wall lower down. Cut stone – smoother than C14 stonework. Bell stuck and cannot now be rung.
<b>Historic significance</b>	Neutral – Part of the 1970's restoration. It has now become part of the history of the Chapel.
<b>Appearance</b>	Neutral/negative – see description of stonework and pointing (above).
<b>Issues</b>	Water is said to run down bell rope. This may be due to condensation in the plastic tubing through which the bell rope passes at a high level. Bell is probably too light for it to work for long outside.
<b>Policies</b>	Repair bell; consider new heavier bell.

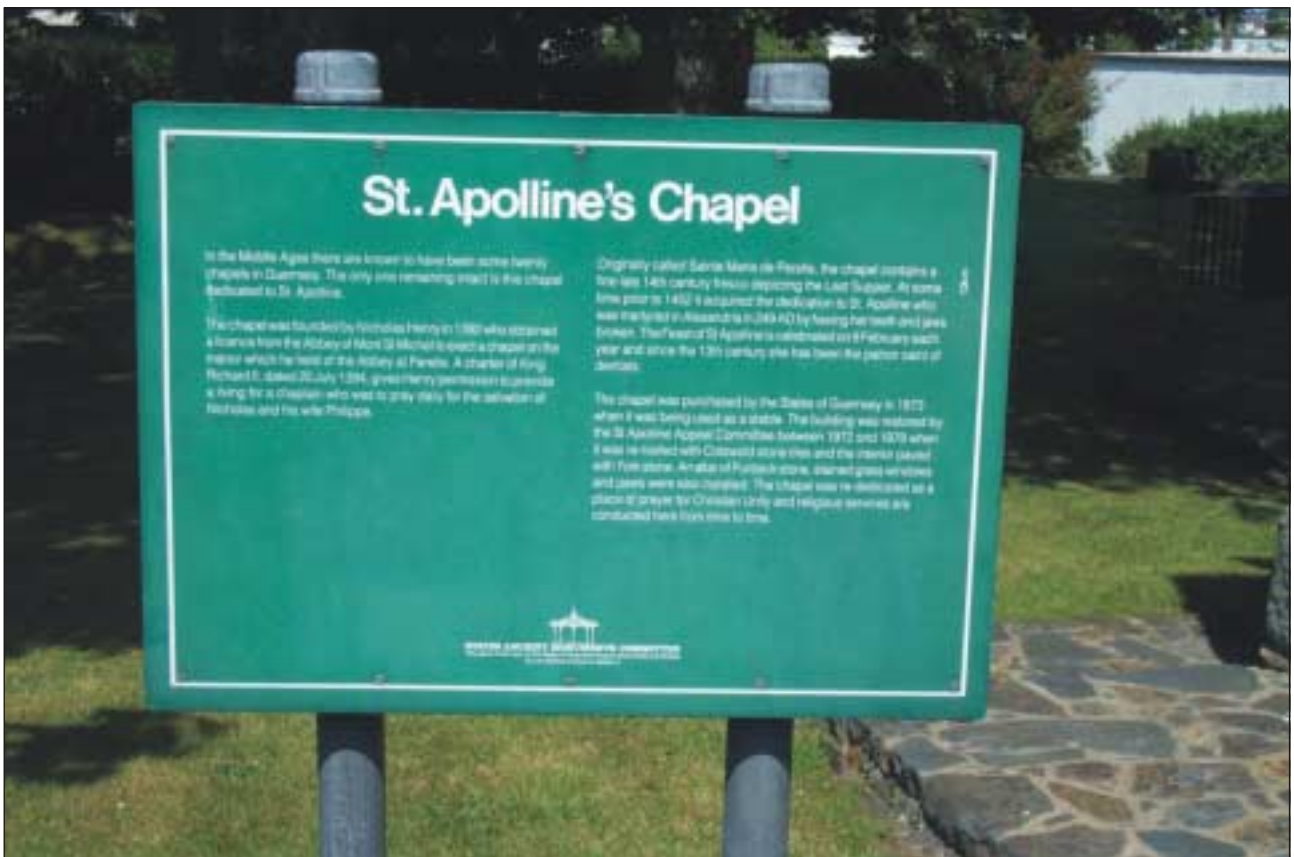
<b>No. 28</b>	<b>Two information boards outside Chapel</b>
<b>Date &amp; source</b>	After 1978
<b>Description</b>	Two States Ancient Monuments Committee information boards briefly describing history of the Chapel. Green metal sign on aluminium posts
<b>Historic significance</b>	Negative: no historic significance
<b>Appearance</b>	Negative: The information boards are presently of poor quality design, and their siting intrusive
<b>Issues</b>	
<b>Policies</b>	The type of information to be provided should be considered. Boards should be designed to a high graphic standard, to be attractive in their own right and sited discreetly, so as not to be visually intrusive.

One of two signs outside the chapel (28)

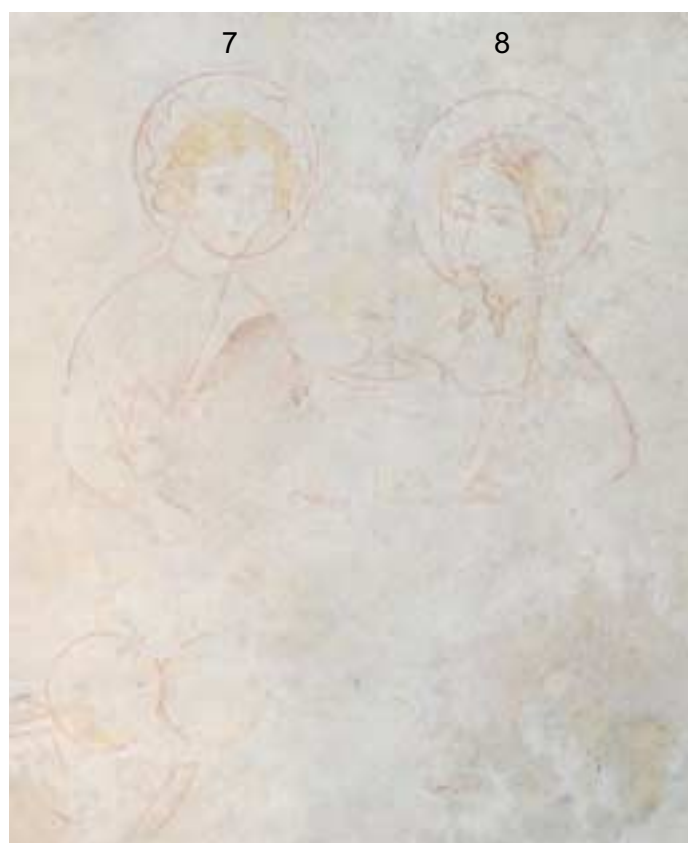
Wall painting of two Apostles (7 and 8).

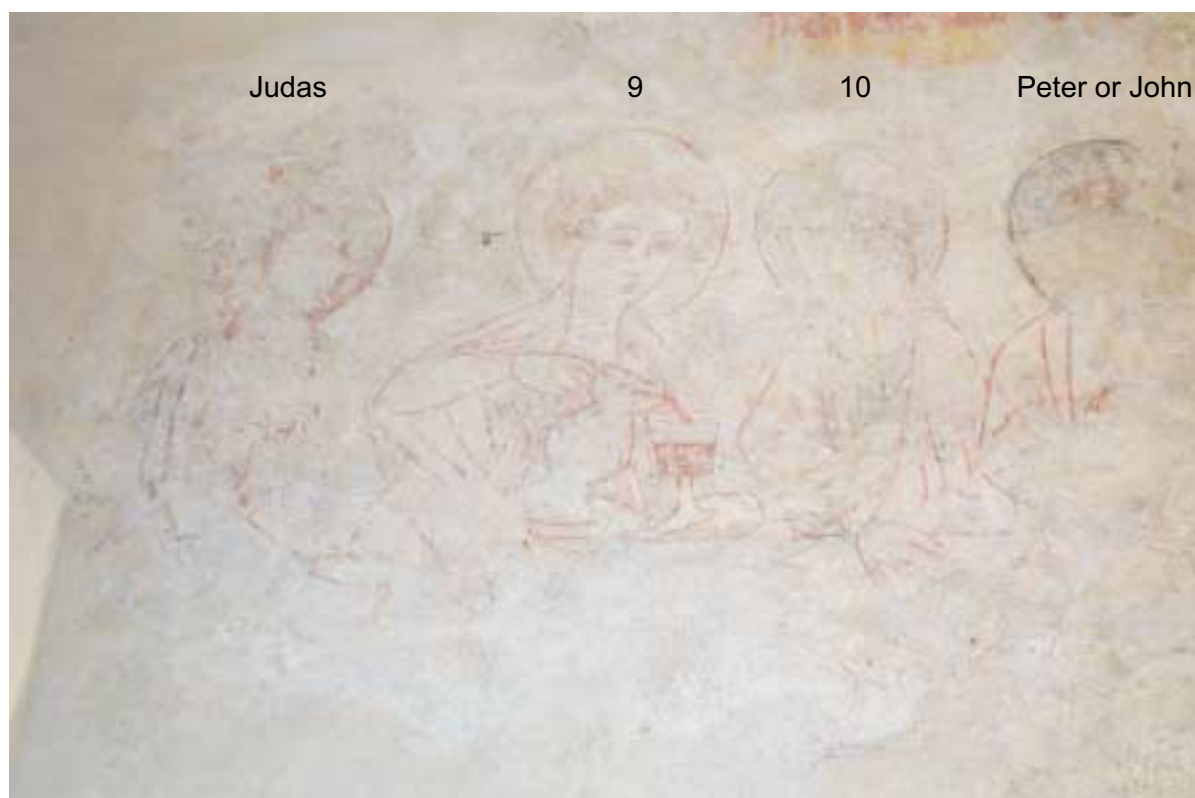
Wall painting of four Apostles to the right of Christ including Judas (11) and Peter or John (2).

To the left of the central group (1-4) is a further pair of interacting Apostles (9 and 10), the one on the left (9) pouring wine from a large jug into a glass held out by his companion (10). The outlines of the younger man on the left (9) are relatively well preserved, although there are losses particularly in the hair and on the lower body. The right-hand figure (10) is more damaged, particularly around the face, where the features including his elegantly forked beard are only just discernible. Again a

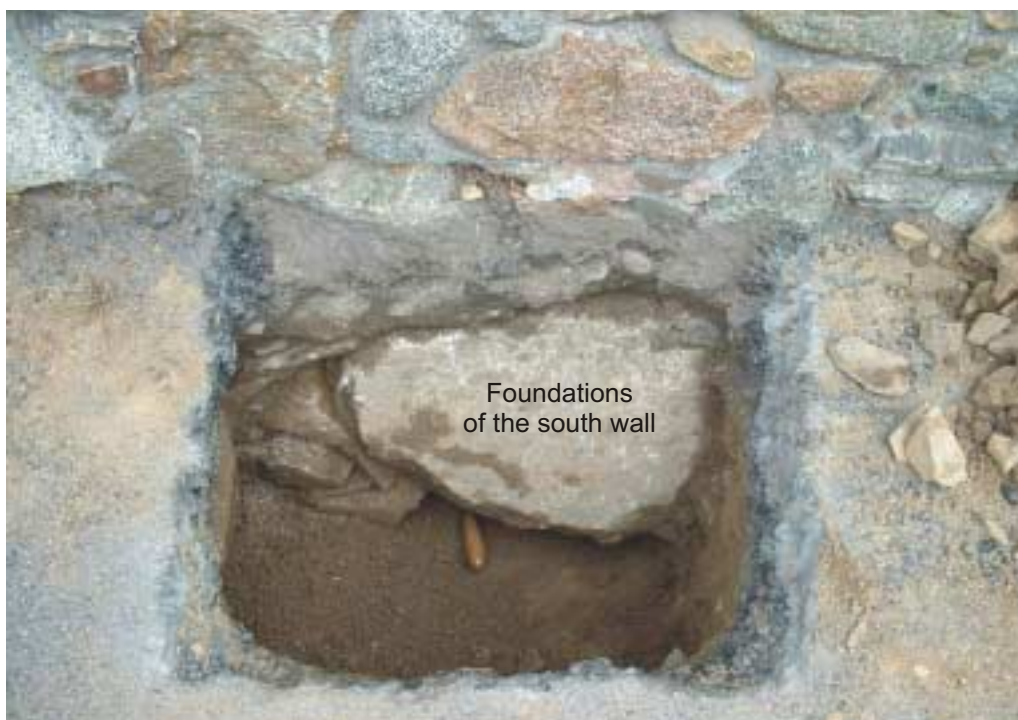
Test pit 1 viewed from the south.

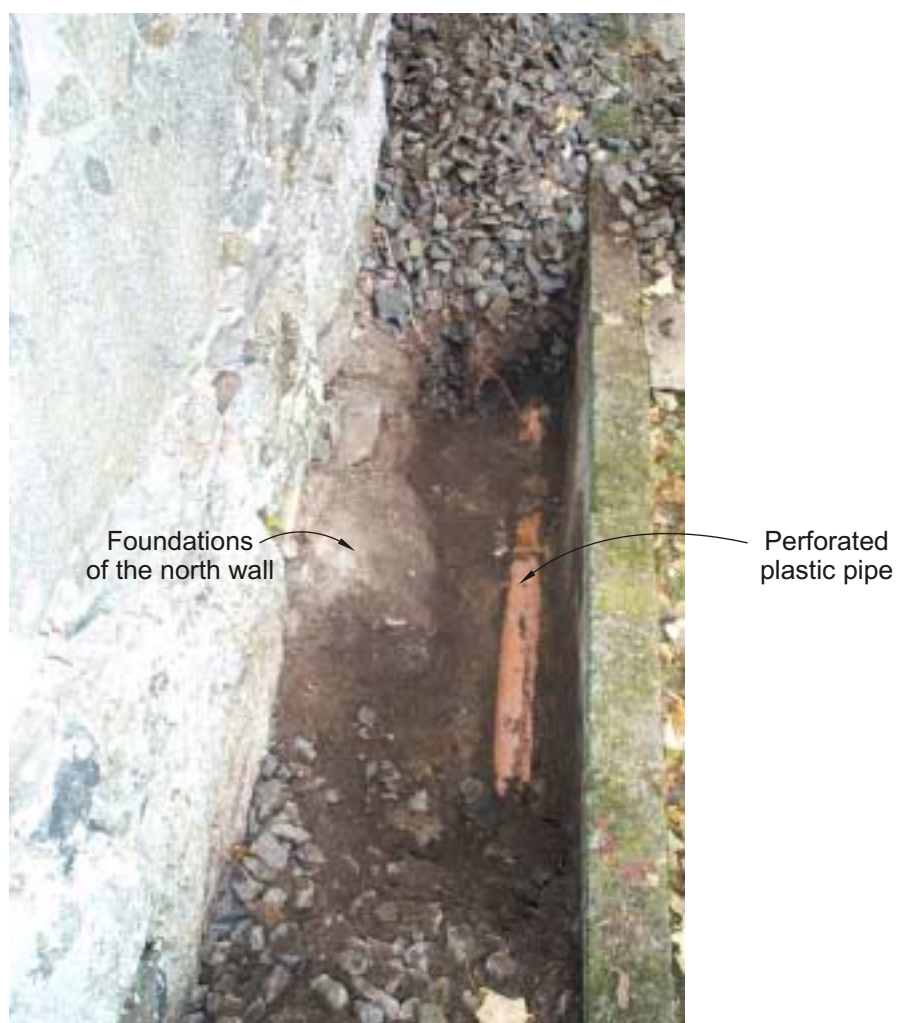
Test pit 2 viewed from the east.

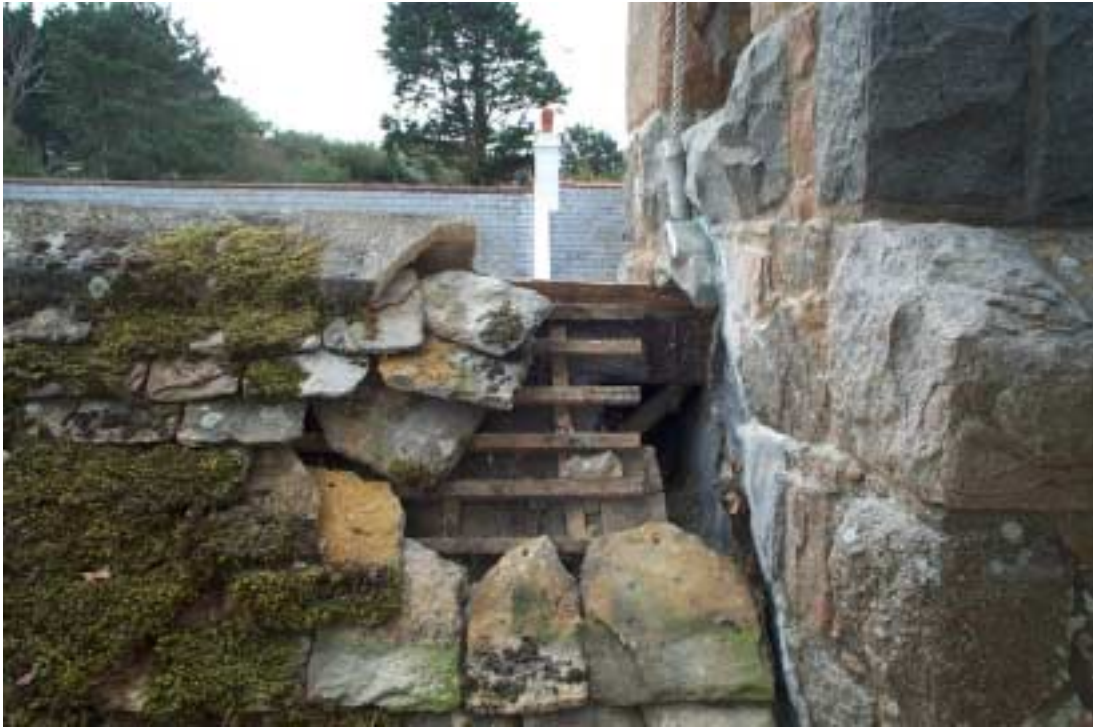
Area 3: removal of Cotswold stone roof slates.

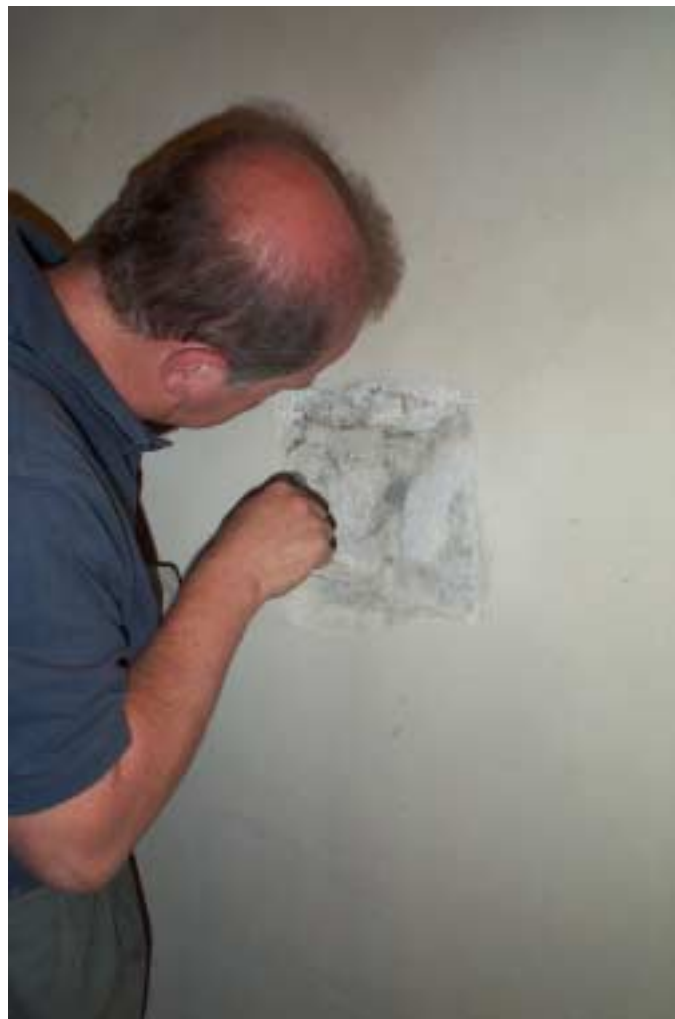
Investigation of Area 4.

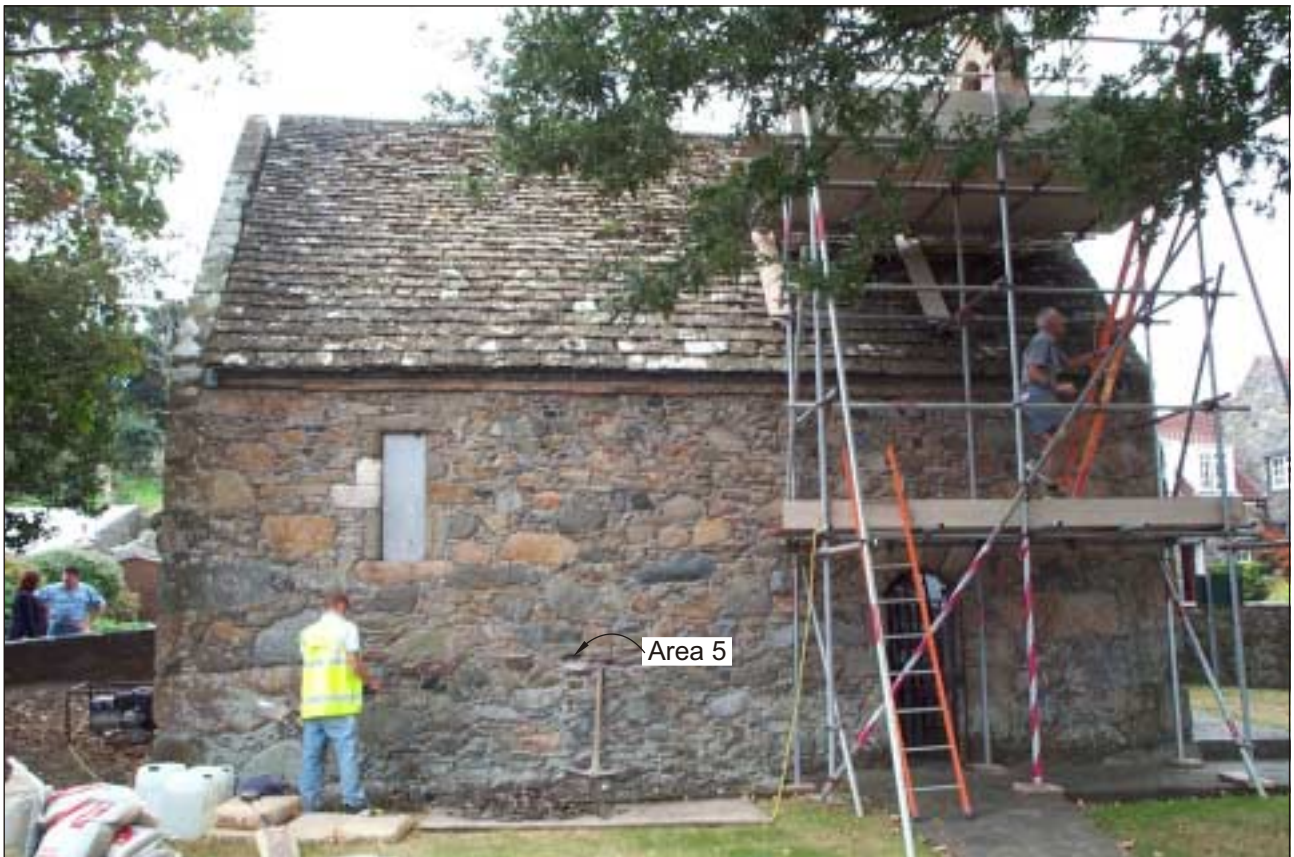
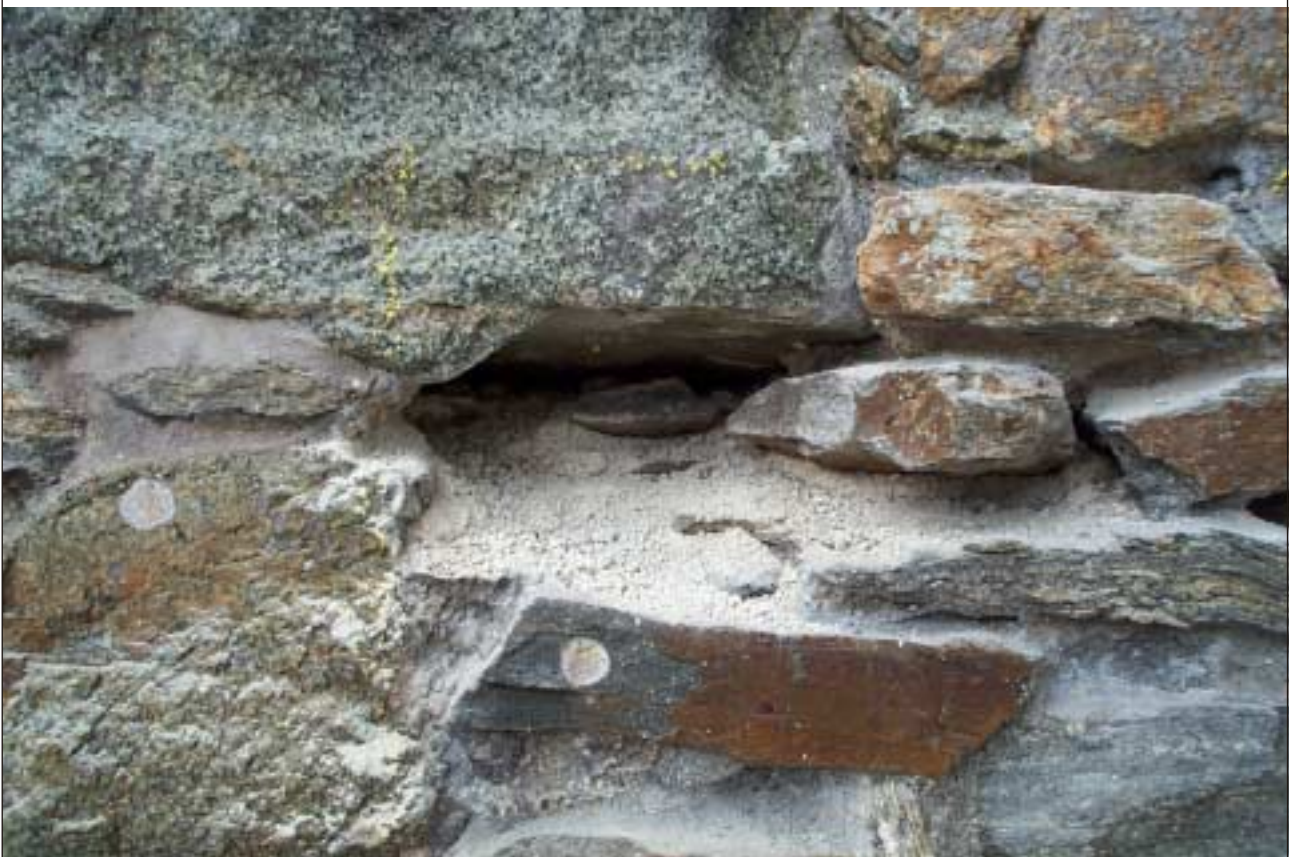
***Area 5***

Location of Area 5.

Detail of Area 5.

Removal of a small area of the exterior pointing revealed the original late fourteenth century coarse shelly lime mortar.
