Iona II, Lundy

Designated Site Assessment:

Full Report

Ref: 53111.03z

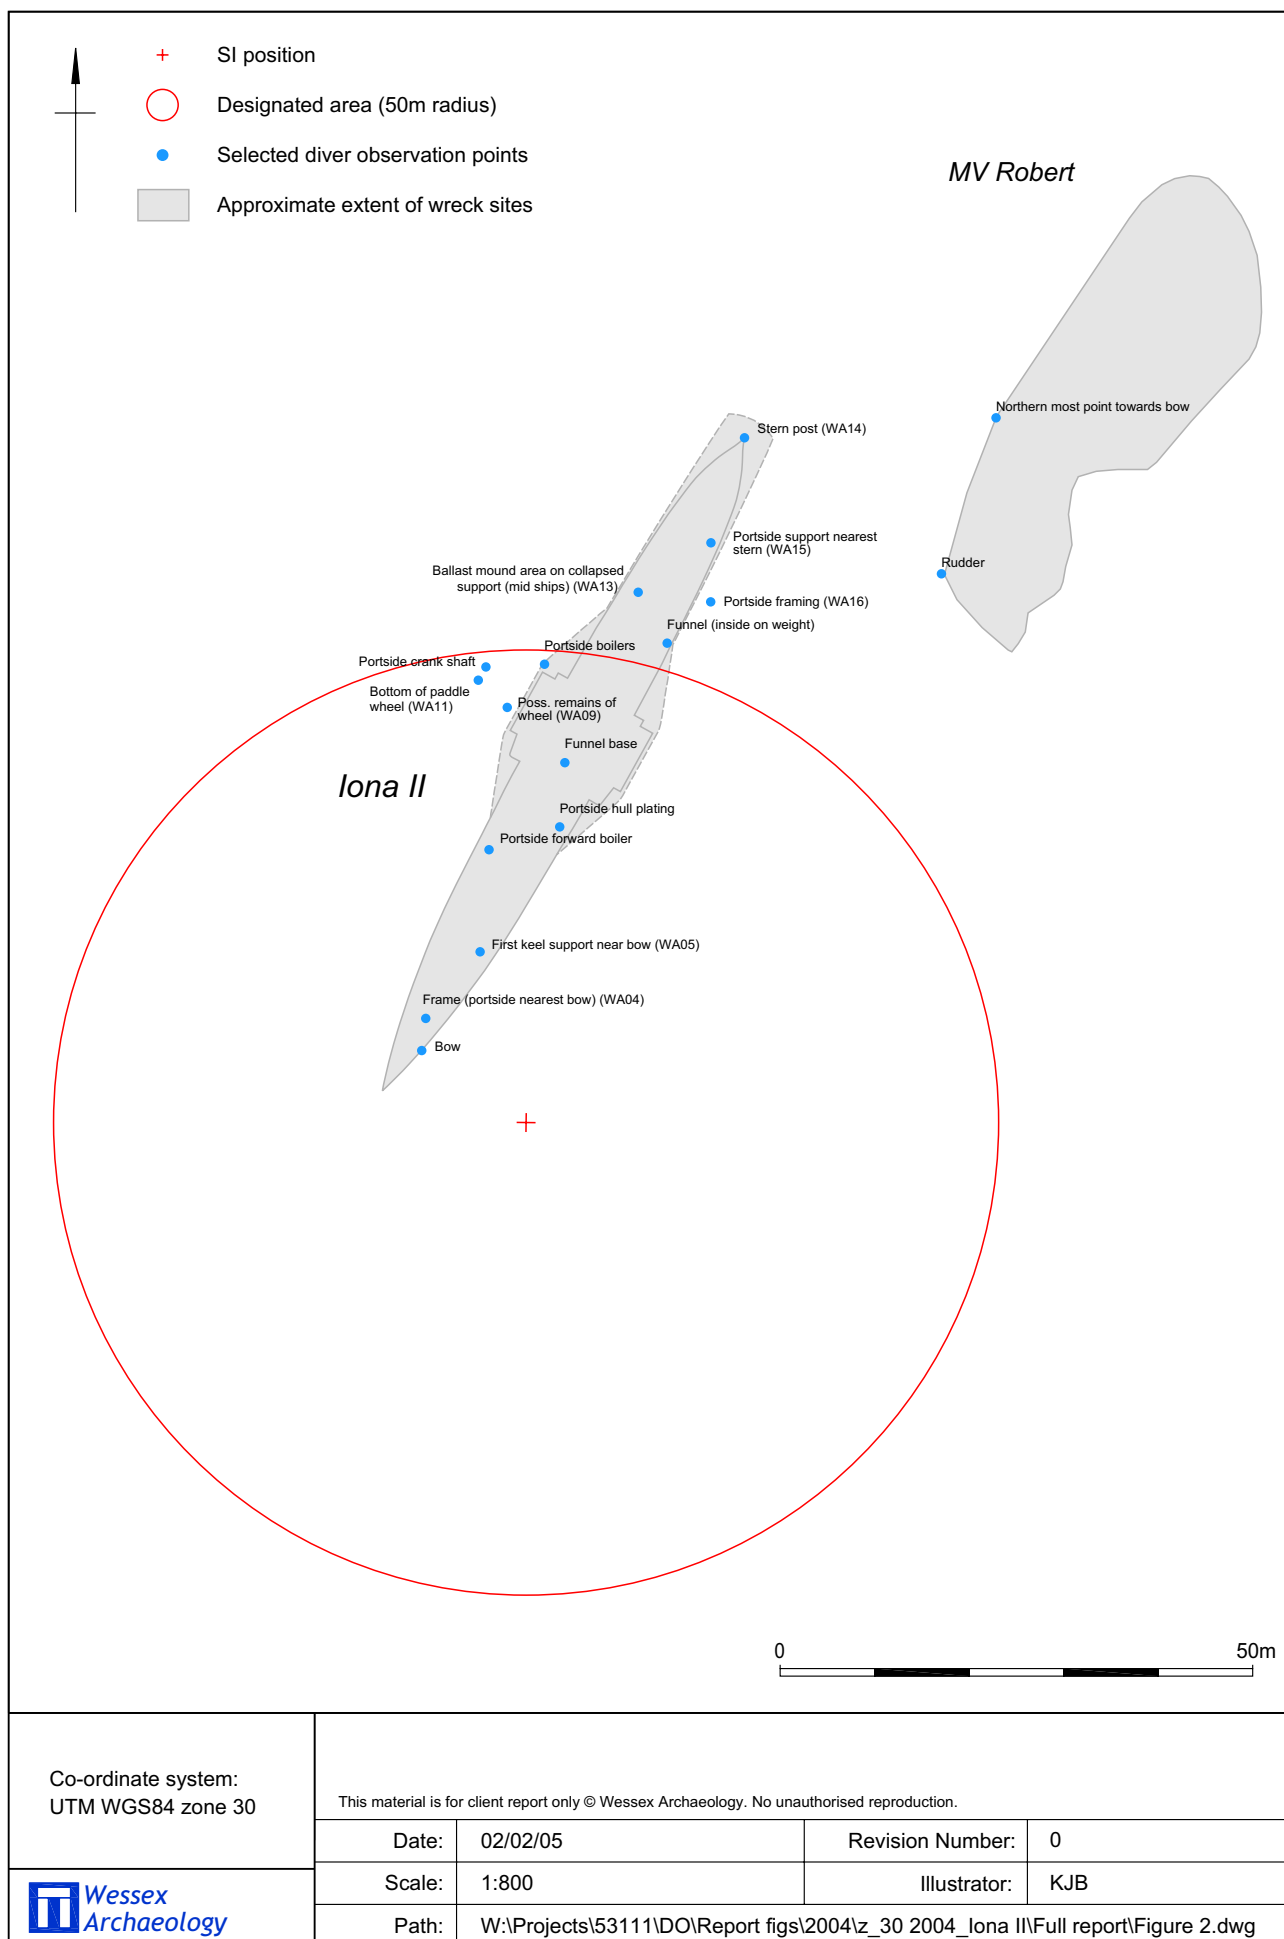
Figure 2

- 5.2.5. This positional data shows that the whole of the *Iona II* does not lie within the designated area. This is illustrated in **Figure 2**.

Position of The *Iona II* relative to the designated area and the *MV Robert*

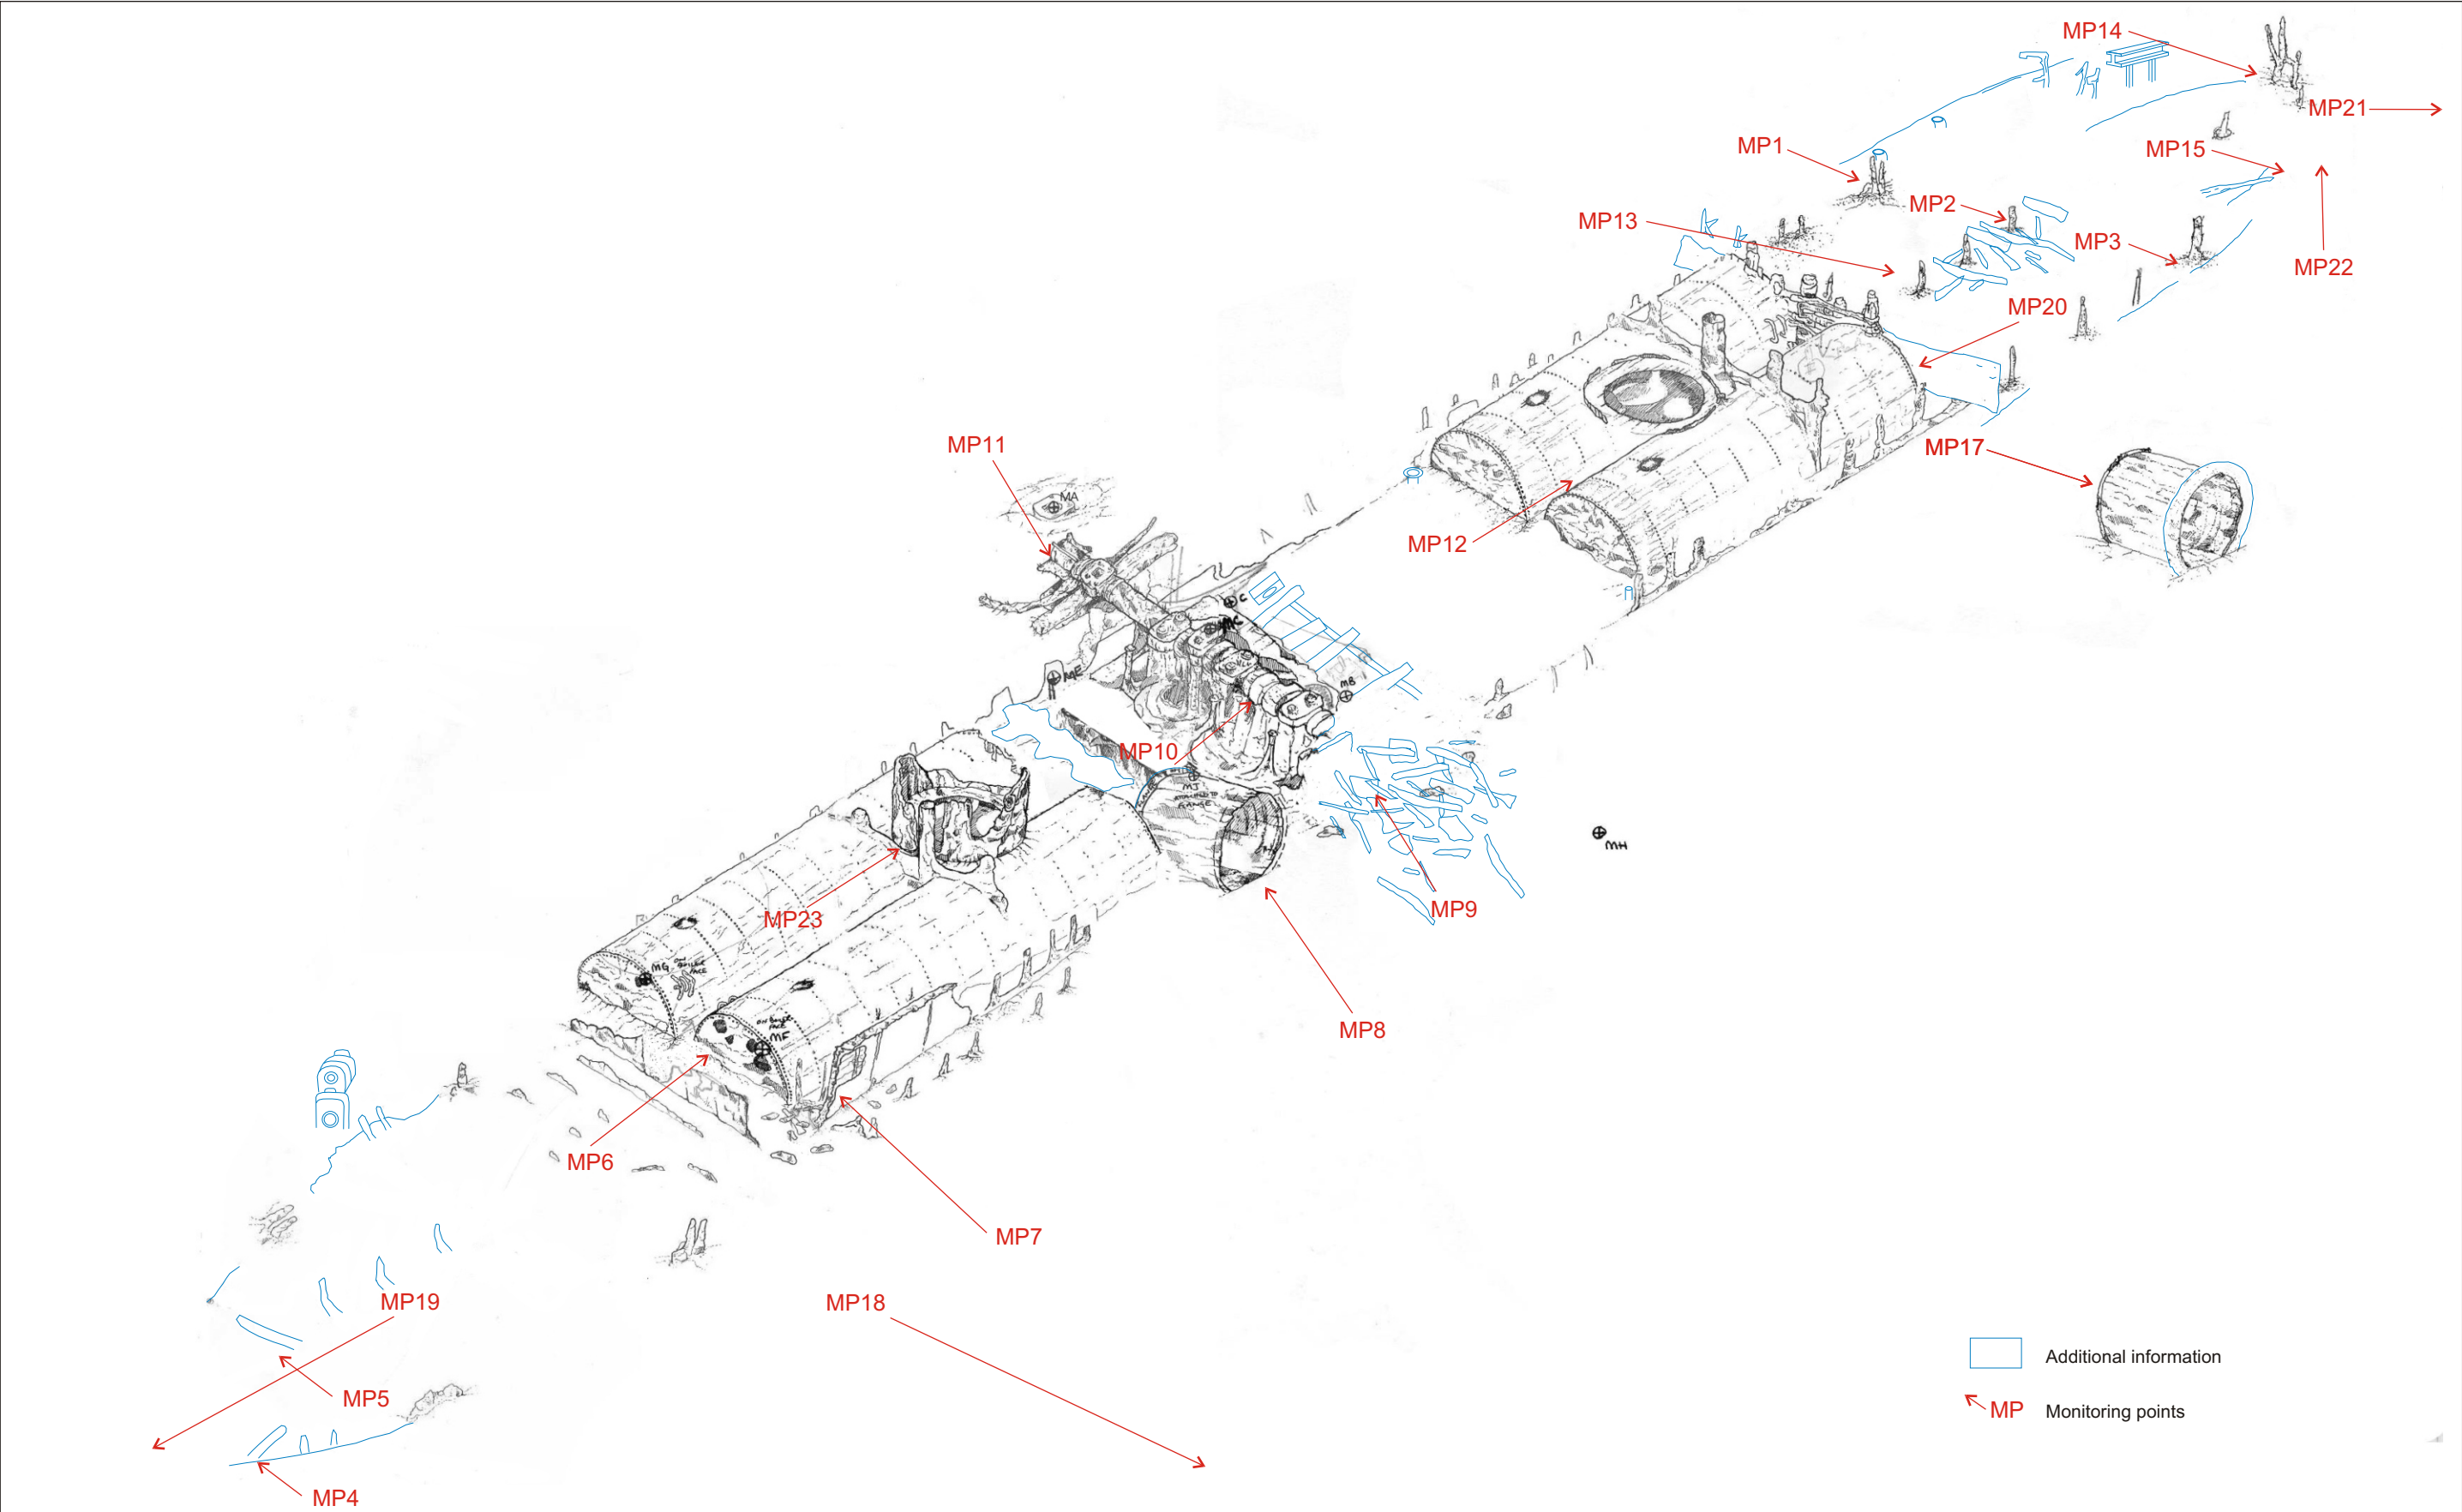
Figure 5

- 5.5.16. The aft area is similar to the bow area in that little is visible above the level of the seabed. An outline of the hull can be seen on the seabed (**Figure 5**), tapering to meet together at what is probably the stern. At the stern there are what appears to be the remains of the stern post (**Plate 8**), but no sign of the rudder itself.
- 5.5.17. Other visible remains include the centre support stanchions running along the centre line towards the rear boilers, and the remains of frames along both the port and starboard side (**Figure 5**). The remains of what may be ballast can be seen to the north of the stern boilers.

Updated isometric sketch plan of site produced by WA
