Sainte Apolline's Chapel St. Saviour's, Guernsey

Summary of the Conservation and Management Plan

DRAFT
Ref: 53511.05
December 2003

**Ste Apolline's Chapel,
St Saviour's Parish,
Guernsey**

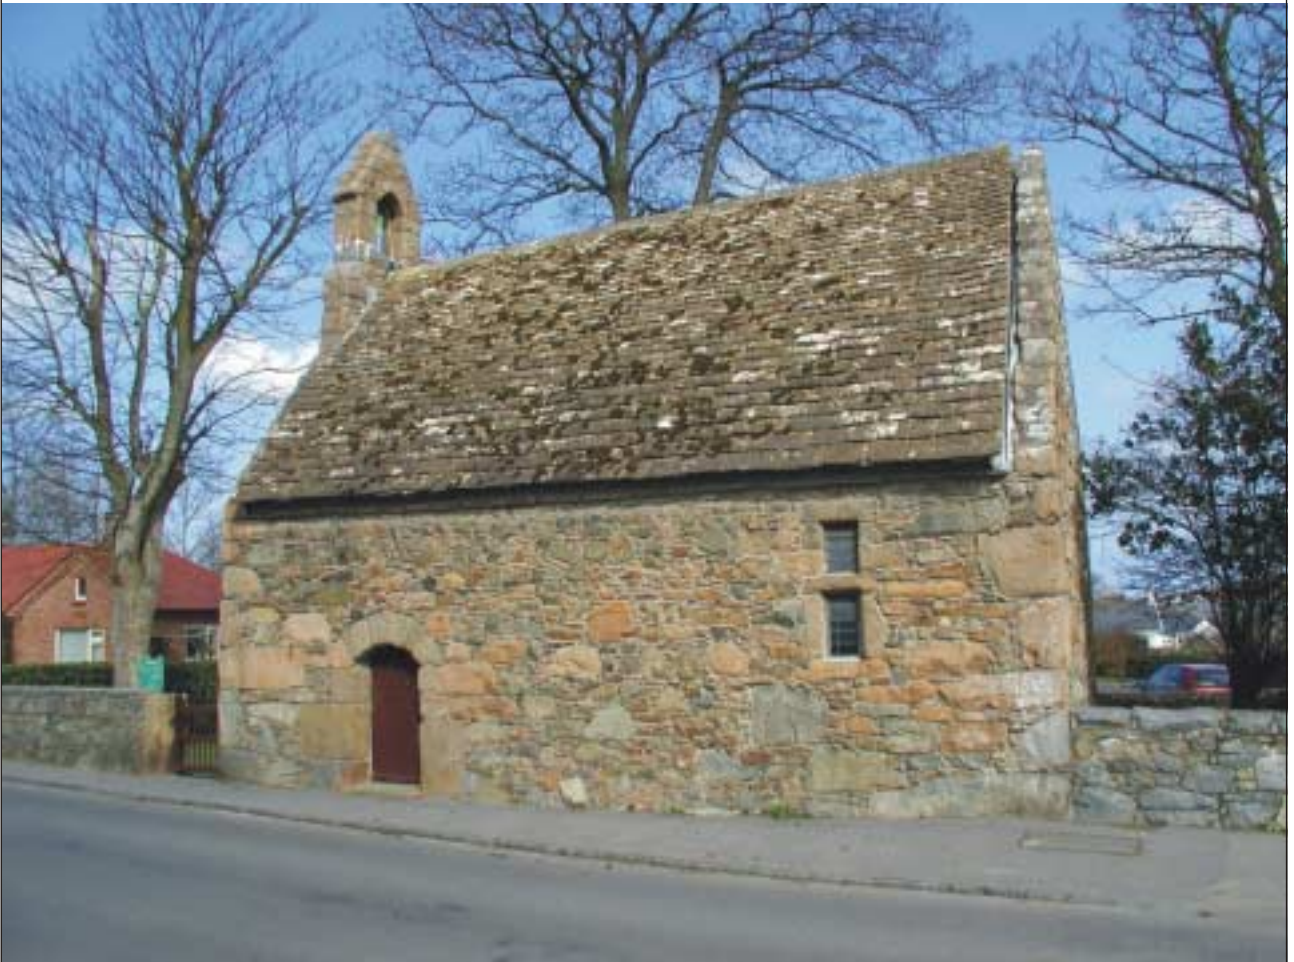
Ste Apolline's Chapel today showing 1970's bellcote and roof.

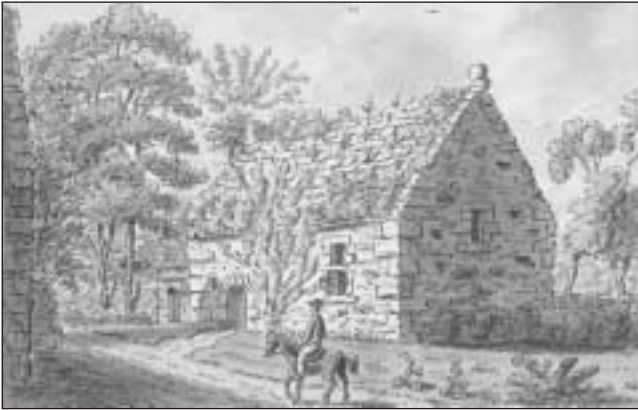
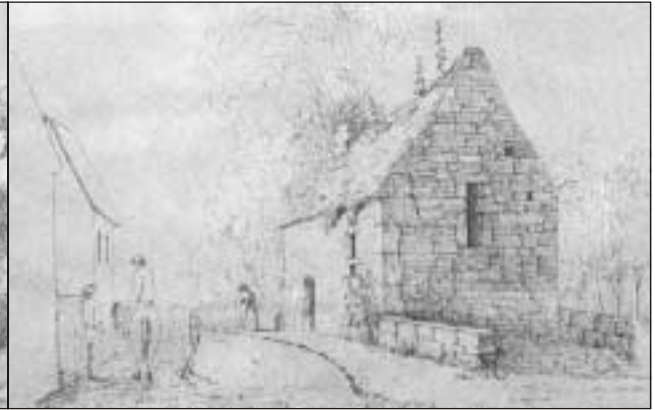
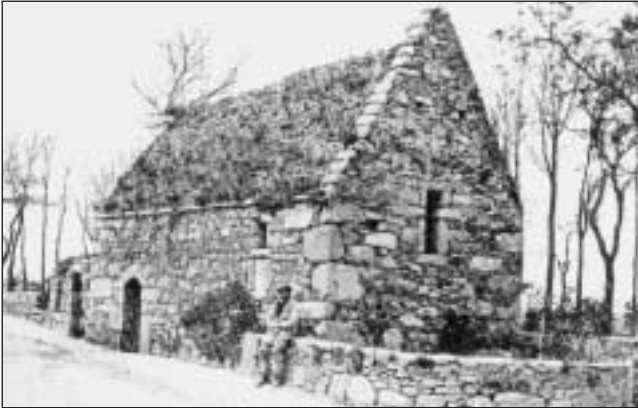
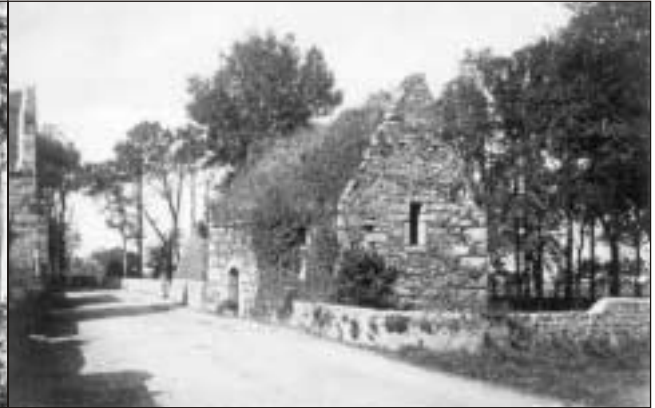
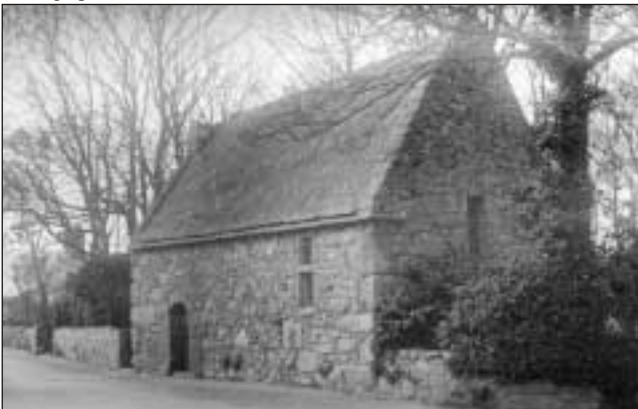
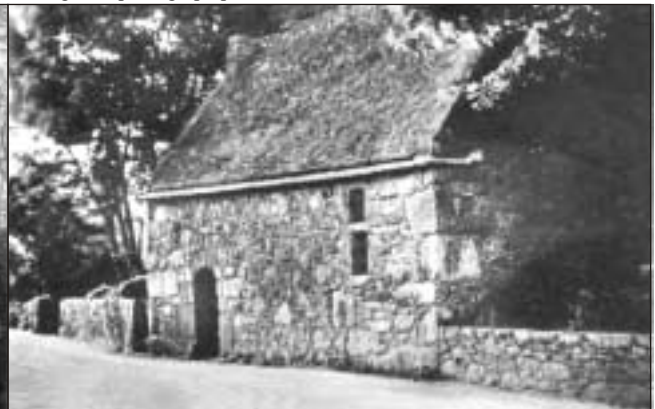
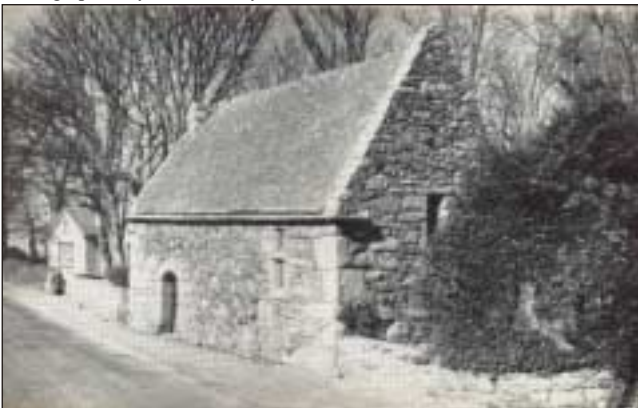
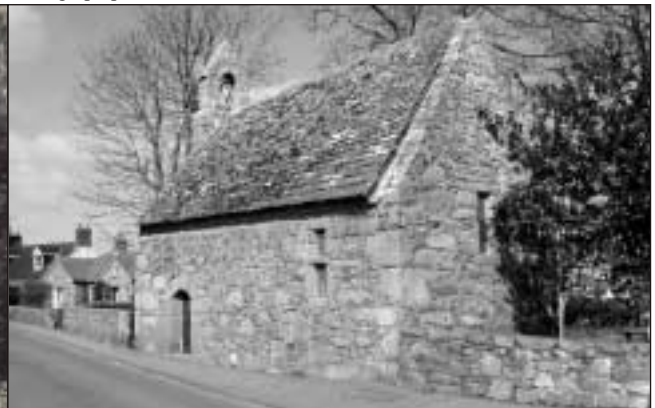
Joshua Gosselin watercolour 1793.

Peter Le Lièvre lithograph c.1850.

Photograph c.1870.

T. Singleton photograph post 1873.

Photograph early 20th century.

Photograph pre 1939.

Photograph c.1953.

Photograph present.

In 1873, the States bought the Chapel for £120 and it became the first site in the care of the Ancient Monuments Committee. Photographic evidence indicates that a major programme of repair was undertaken at the Chapel in the 1920s, but apart from that and basic maintenance, little other work took place until the 1970s.

In 1971, architects from the Brandt Potter Hare Partnership made proposals for its restoration on behalf of the Guernsey Council of Churches, and this was carried out during the 1970s in phases as money became available. The work included replacement of the roof, the installation of heating under a York stone floor, new interior furnishings, new windows and doors and the restoration of the interior plaster and paintings.
