Dotton Mill, Dotton, Near Otterton, Devon

Archaeological Evaluation and Assessment of Results

Ref: 62507.01

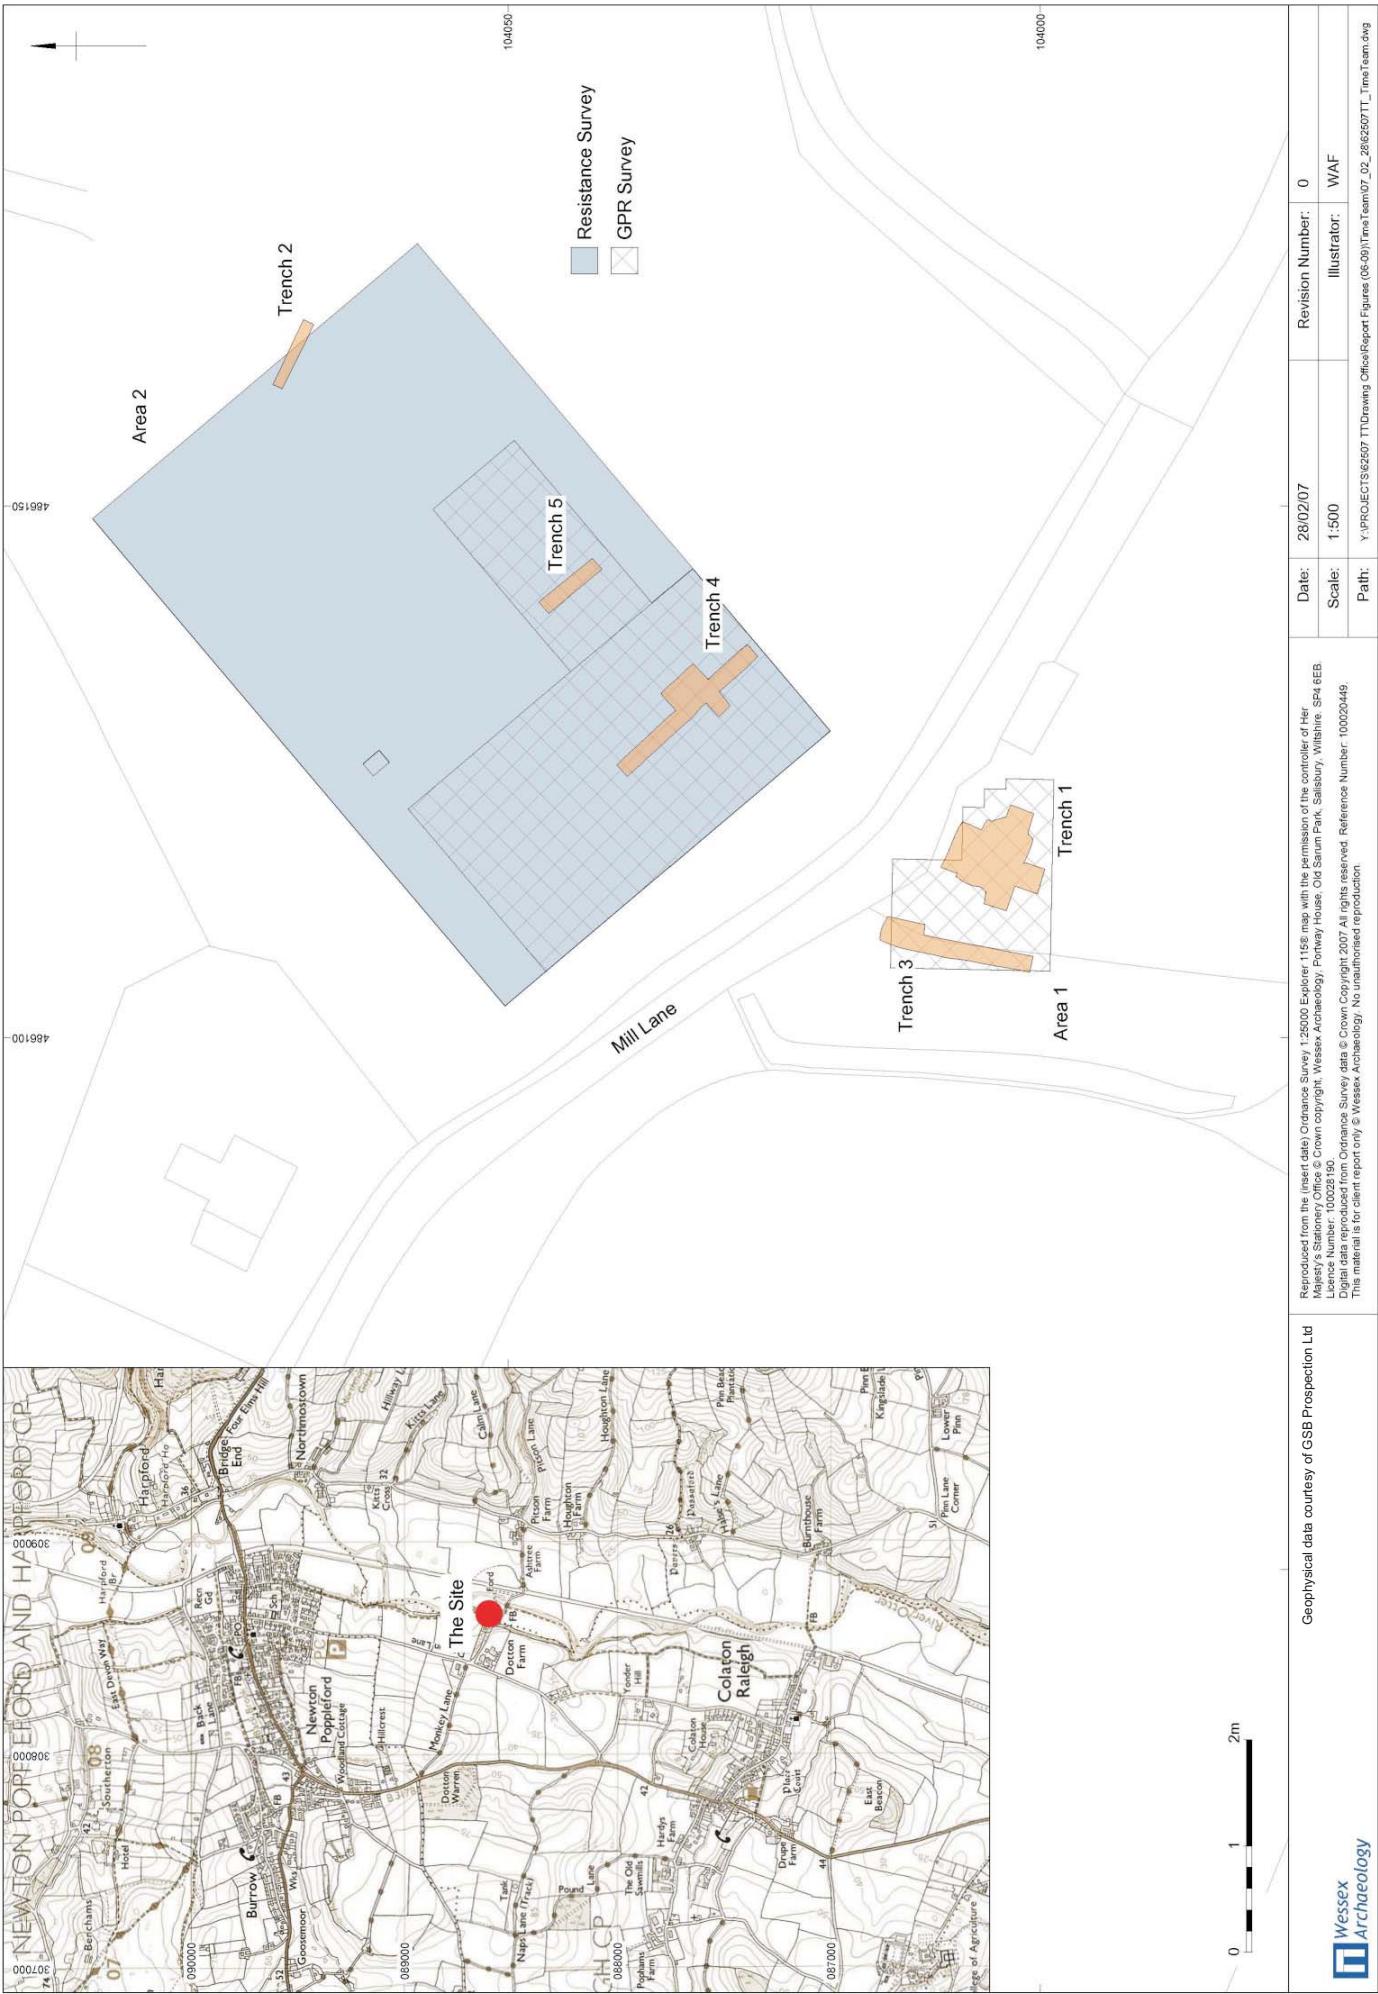
Figure 1

Site location and position of Trenches

- 1.1.1 Wessex Archaeology was commissioned by Videotext Communications Ltd to undertake a programme of archaeological recording and post-excavation work on an archaeological evaluation undertaken by Channel 4's 'Time Team' at the site Dotton Mill, Dotton, near Otterton, Devon (hereafter the 'Site') (**Figure 1**).
- 1.1.2 This report documents the results of archaeological survey and evaluation undertaken by Time Team, and presents an assessment of the results of these works.

- 4.3.29 Trench 2 was placed across the line of the leat and the boundary between the parishes of Colaton Raleigh to the west and Otterton (now Newton Poppleford and Harpford) to the east as identified in the geophysical survey as anomaly (A) (**Figures 1 and 3**). The upper fill of the backfilled leat and the remains of the leat bank were identified below topsoil (201). Following the partial excavation of the leat, an auger survey was undertaken to record its full depth and the earliest fills within it.

- 4.3.35 No datable material was recovered form the backfill deposits of the leat.
- Trench 4 (Figure 6)**
- 4.3.36 Trench 4 was positioned to investigate the mill leat further, and also the possibility of buildings on the higher ground to the west of the leat identified in the geophysics as anomaly (B) (**Figures 1 and 3**).

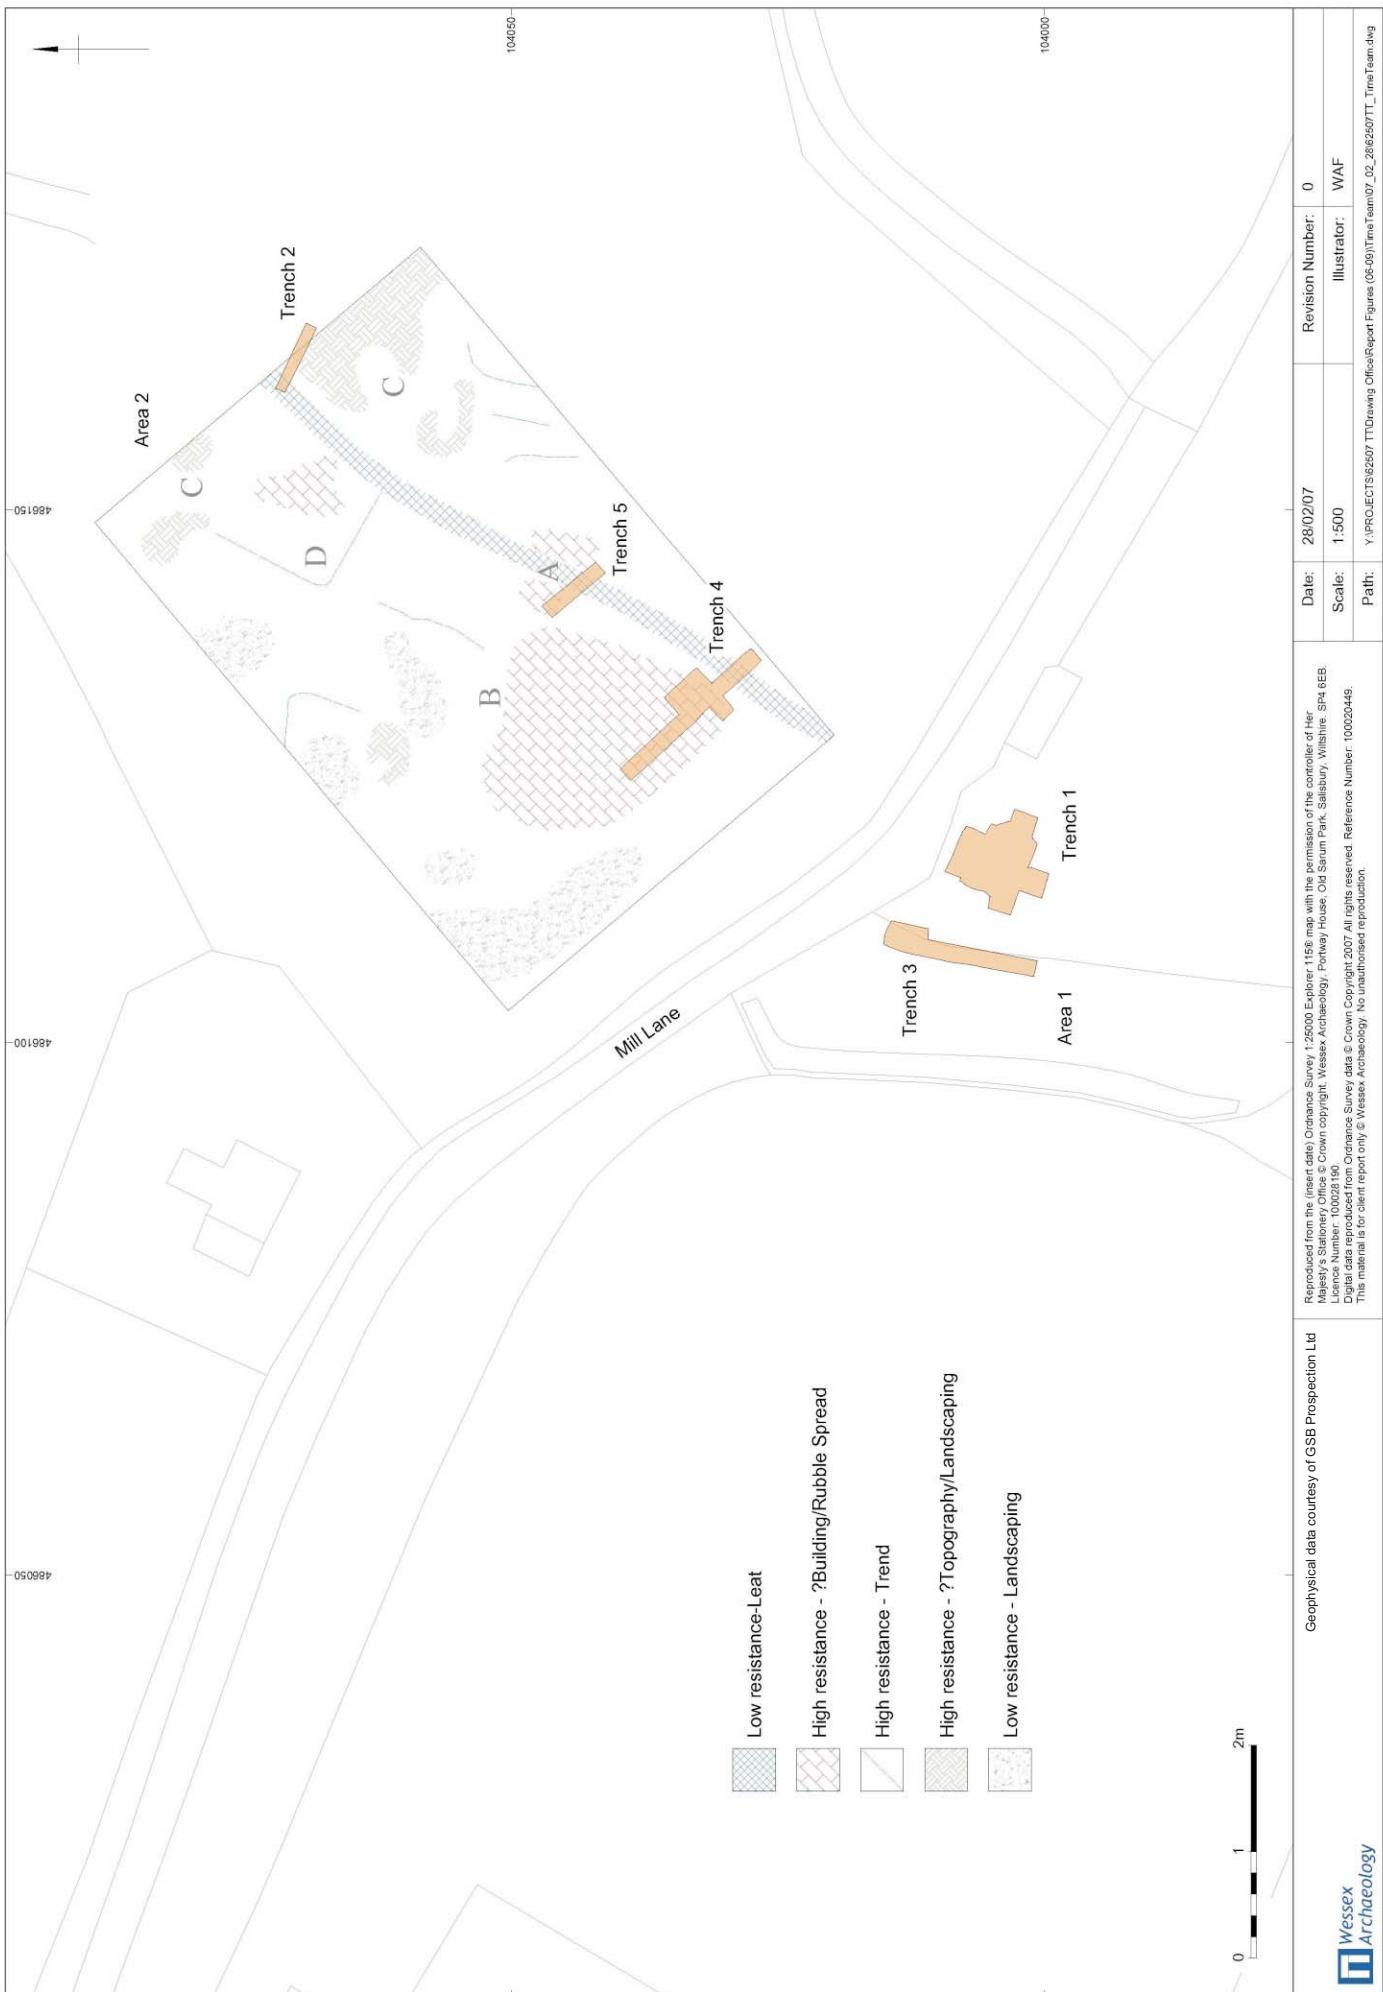
Figure 3

Site location and position of Trenches

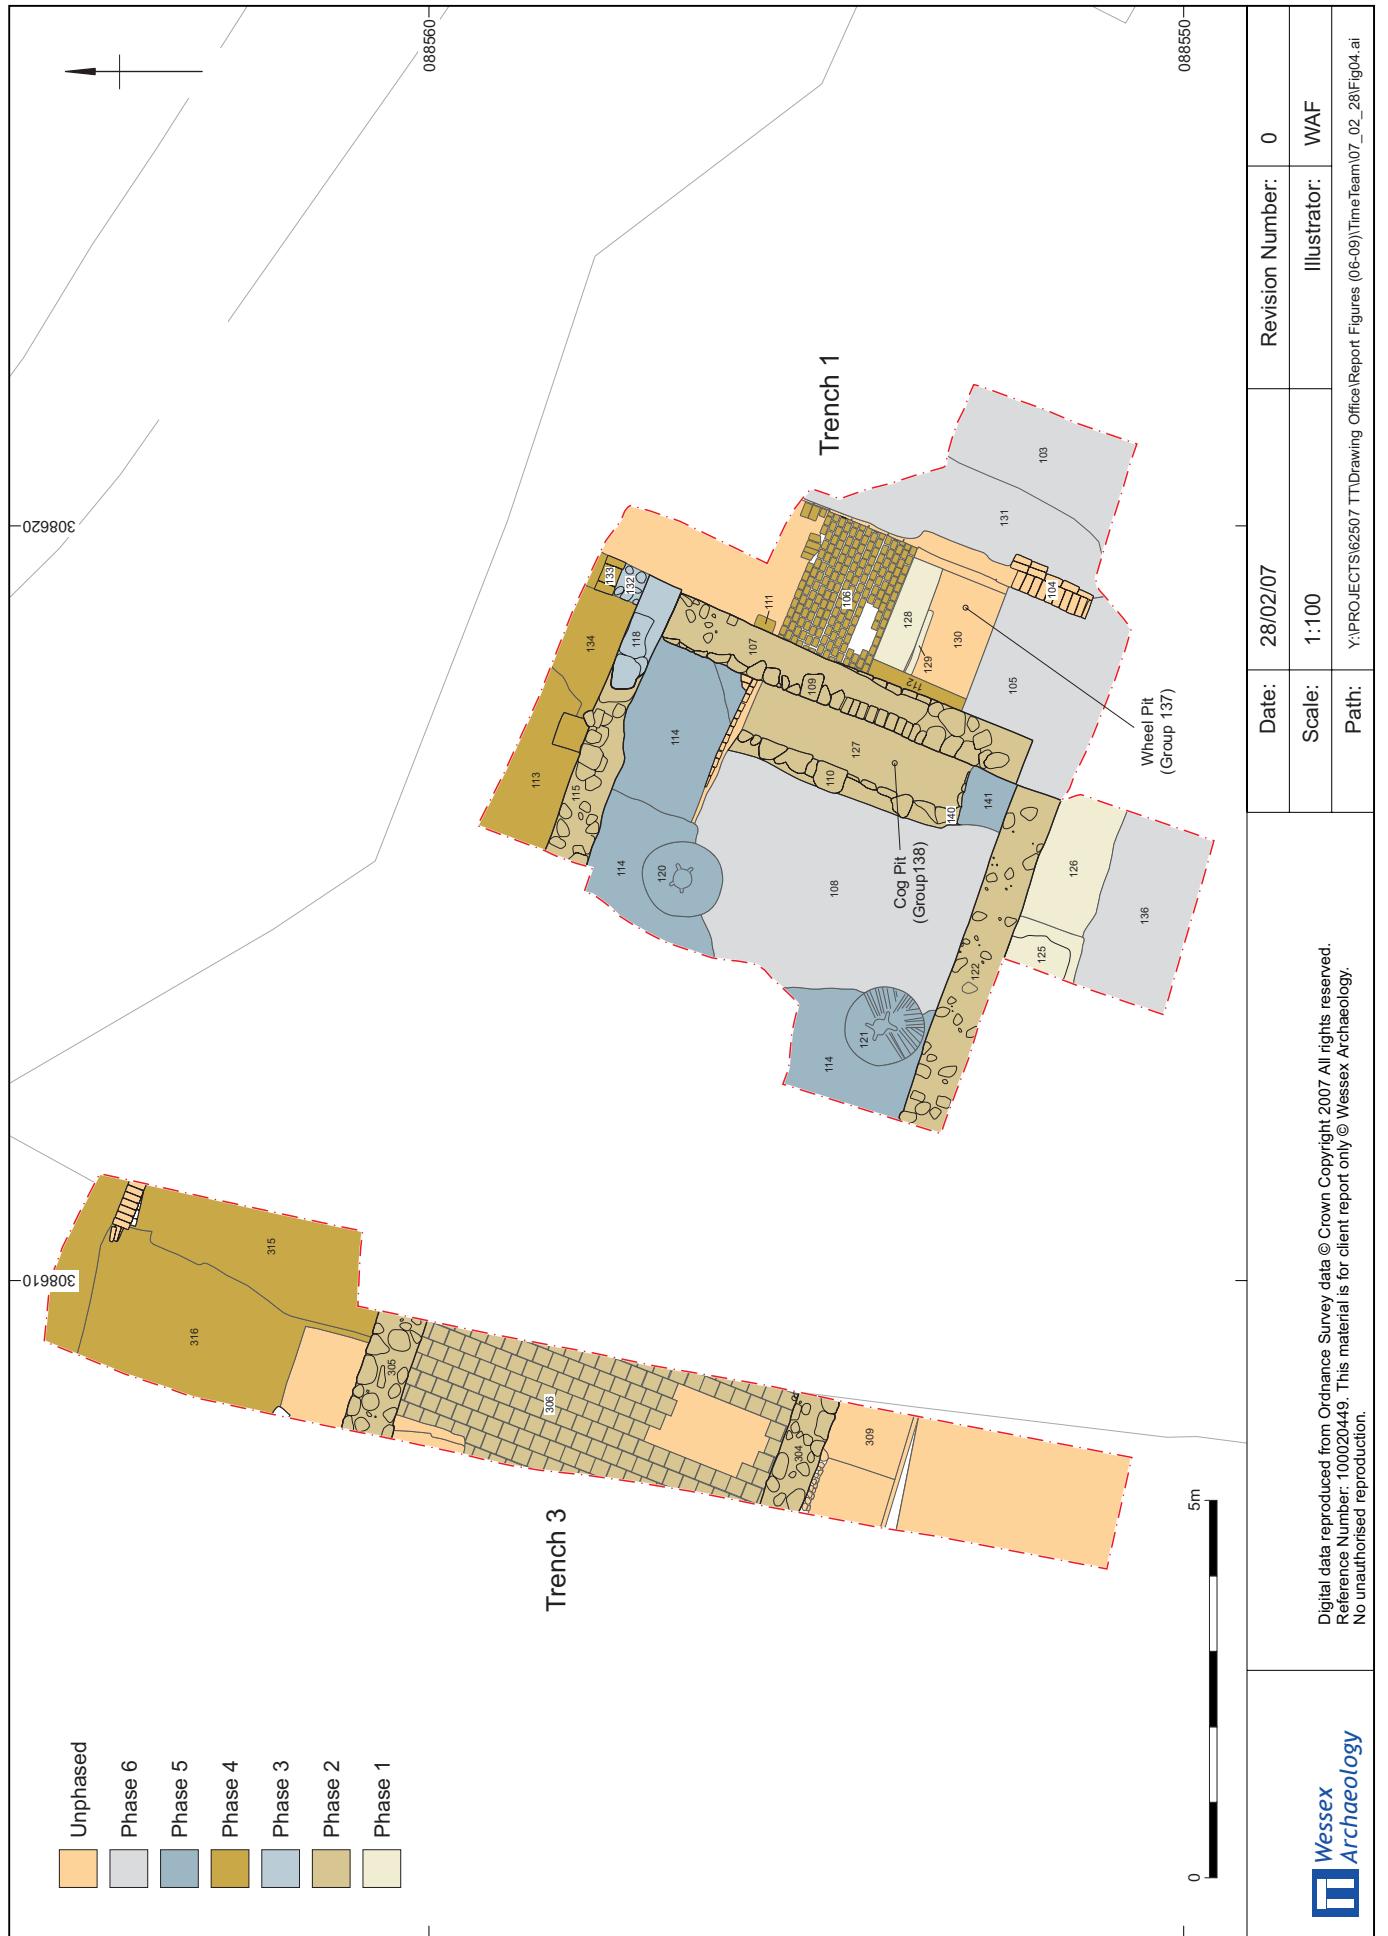
Figure 4

Plan of Trench 1 and 3

Area 1: The Mill (Trenches 1 & 3, Figure 4, Plates 1-6)

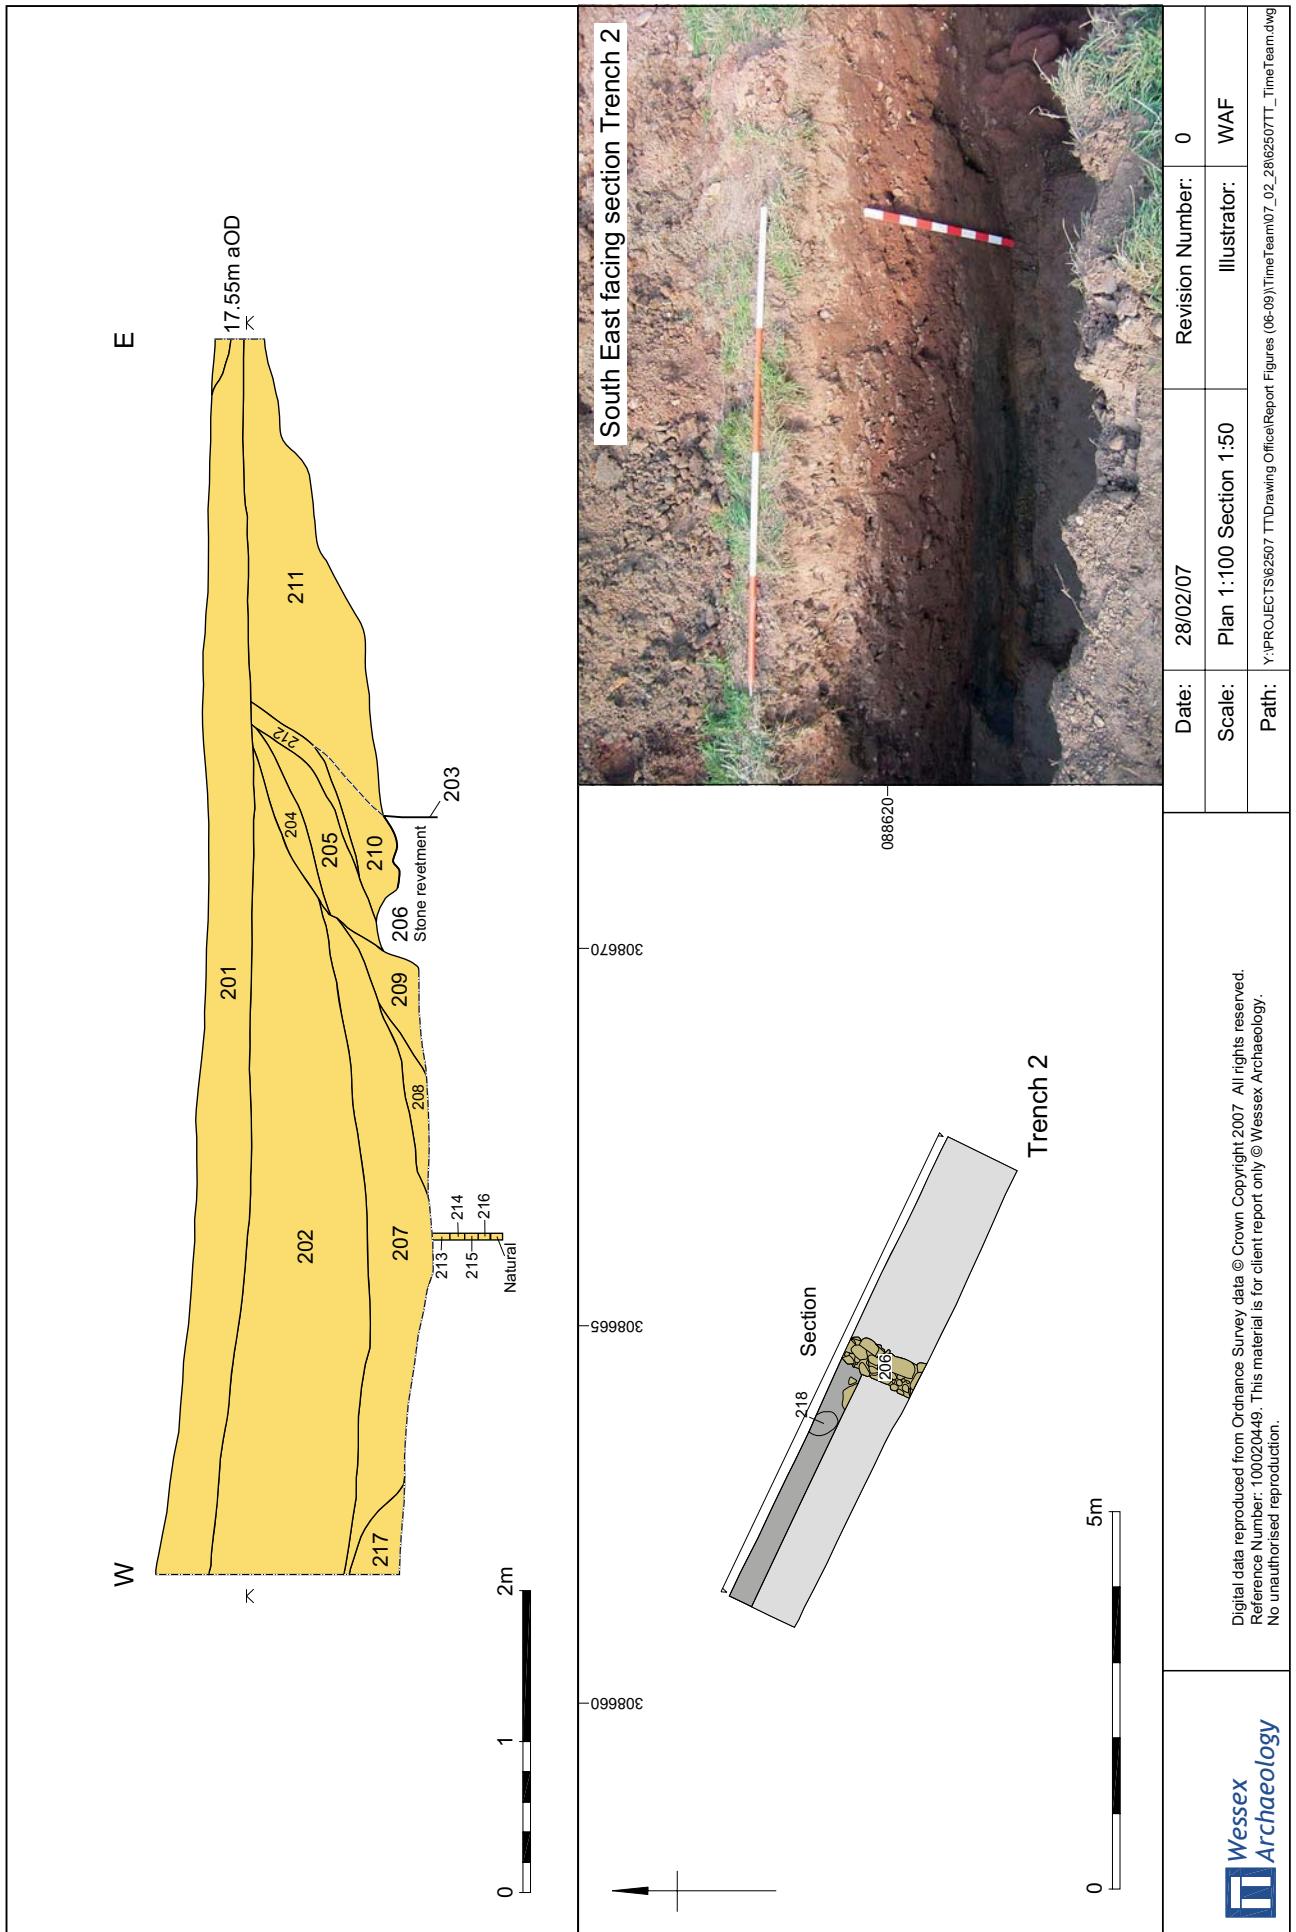
Figure 5

Plan of Trench 2, south east facing section

Trench 2 (Figure 5)

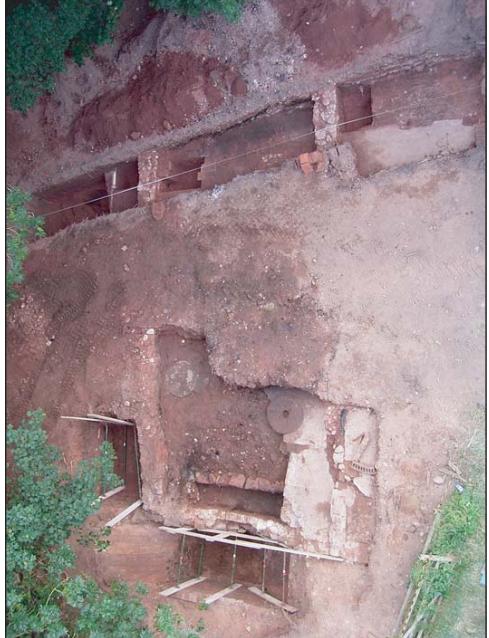
1. Plan of Trenches 1 and 3

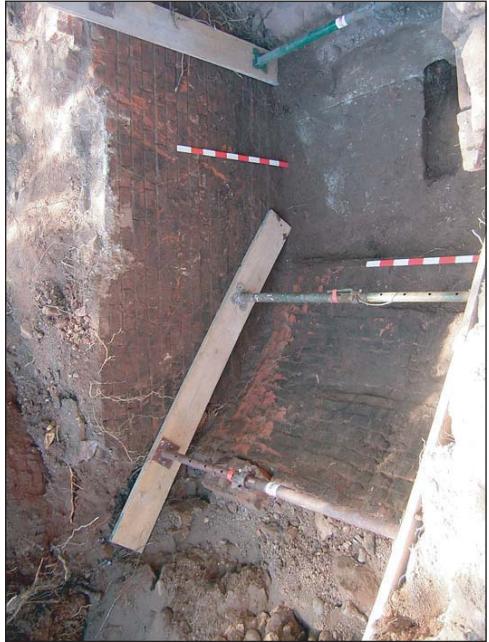
2. West facing shot of Wheel Pit Group (137), showing breast (106), wall (104) and floor (112)

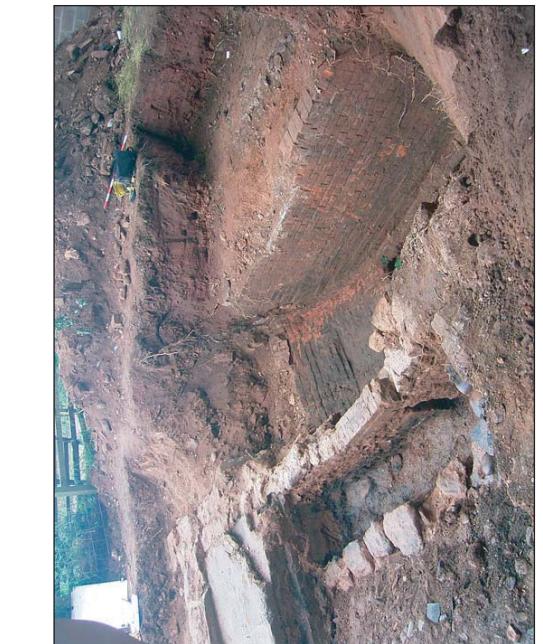
3. Shot of Wheel Pit Group (137) and Cog Pit Group (138) from the south east

- 4.3.7 Wall (107) not only formed the eastern wall of the mill building and the western wall of the wheel pit but it also formed the eastern wall of the cog pit Group (138 (107, 110 and 127)), of which sandstone wall (110) formed the western wall. The base of the cog pit was concave in shape (to allow for the rotation of the wheel) and formed of roughly worked sandstone blocks covered with dark grey mortar (**Plate 3**). The base was recorded as (127). The southern wall (140) of the cog pit was built of roughly hewn sandstone blocks. The cog pit housed the pit wheel which was connected (through wall (107)) to the axle of the water wheel and was used to convert the power from the water wheel to drive the mill machinery.

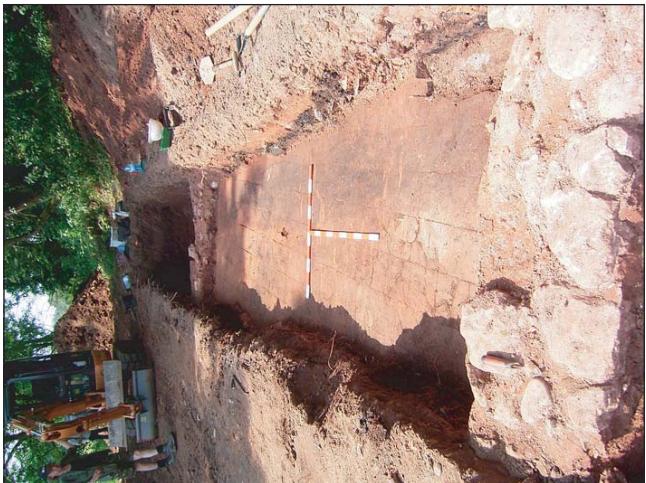
4. Plan of Trench 3 showing wall (305) floor (306) and wall (304) from the north

- 4.3.26 The main walls of the mill were identified with the continuation of walls (115) and (122) from Trench 1, recorded as (305) and (304) respectively, and the floor surface of the mill also identified. Floor surface (306) was constructed of ceramic tiles. The tiles concentrated around the edge of the room had survived well, but those in the centre of the room were very worn (**Plate 4**). A sondage excavated through the tiles revealed that the floor was set into concrete bedding layer (312), which in turn overlay a redeposited natural levelling layer (311). This area of the mill appeared to represent domestic quarters, which was confirmed by a number of local residents who remembered the mill when it was upstanding and recalled the tiled floor as belonging to the kitchen.

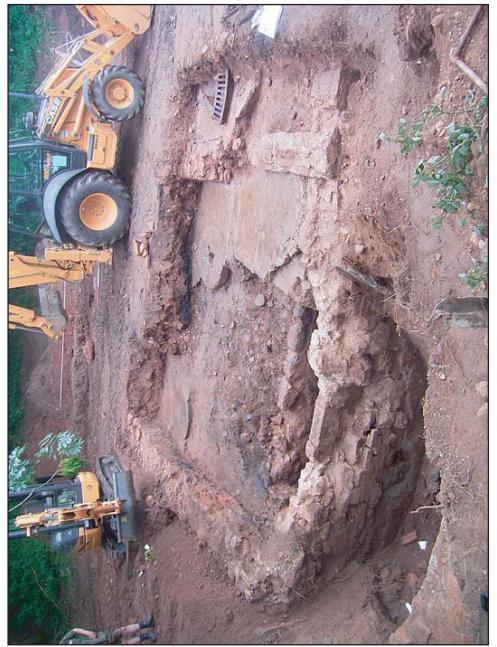
5. Plan of Trench 1 from the east

- 4.3.18 Brick floor (135) was replaced by concrete floor (114), which had two re-used millstones incorporated into the surface (**Plate 5**). Millstone (120) was the top stone or runner stone of a pair of stones, and had been up-ended to show the ‘rynd hole’, a carved socket where the ‘rynd’ (the bracket which holds the runner stone to the spindle and the rest of the gearing mechanism) was positioned. The stone was identified as 19th century on the basis of the rynd hole. (M. Nevell and M. Watts pers. comm.).
