*Iona I,*  
Inner Clyde Estuary, Scotland

Undesignated Site Assessment:  
**Archaeological Report**

**March 2009**

**Ref: 53111.02q-6a**

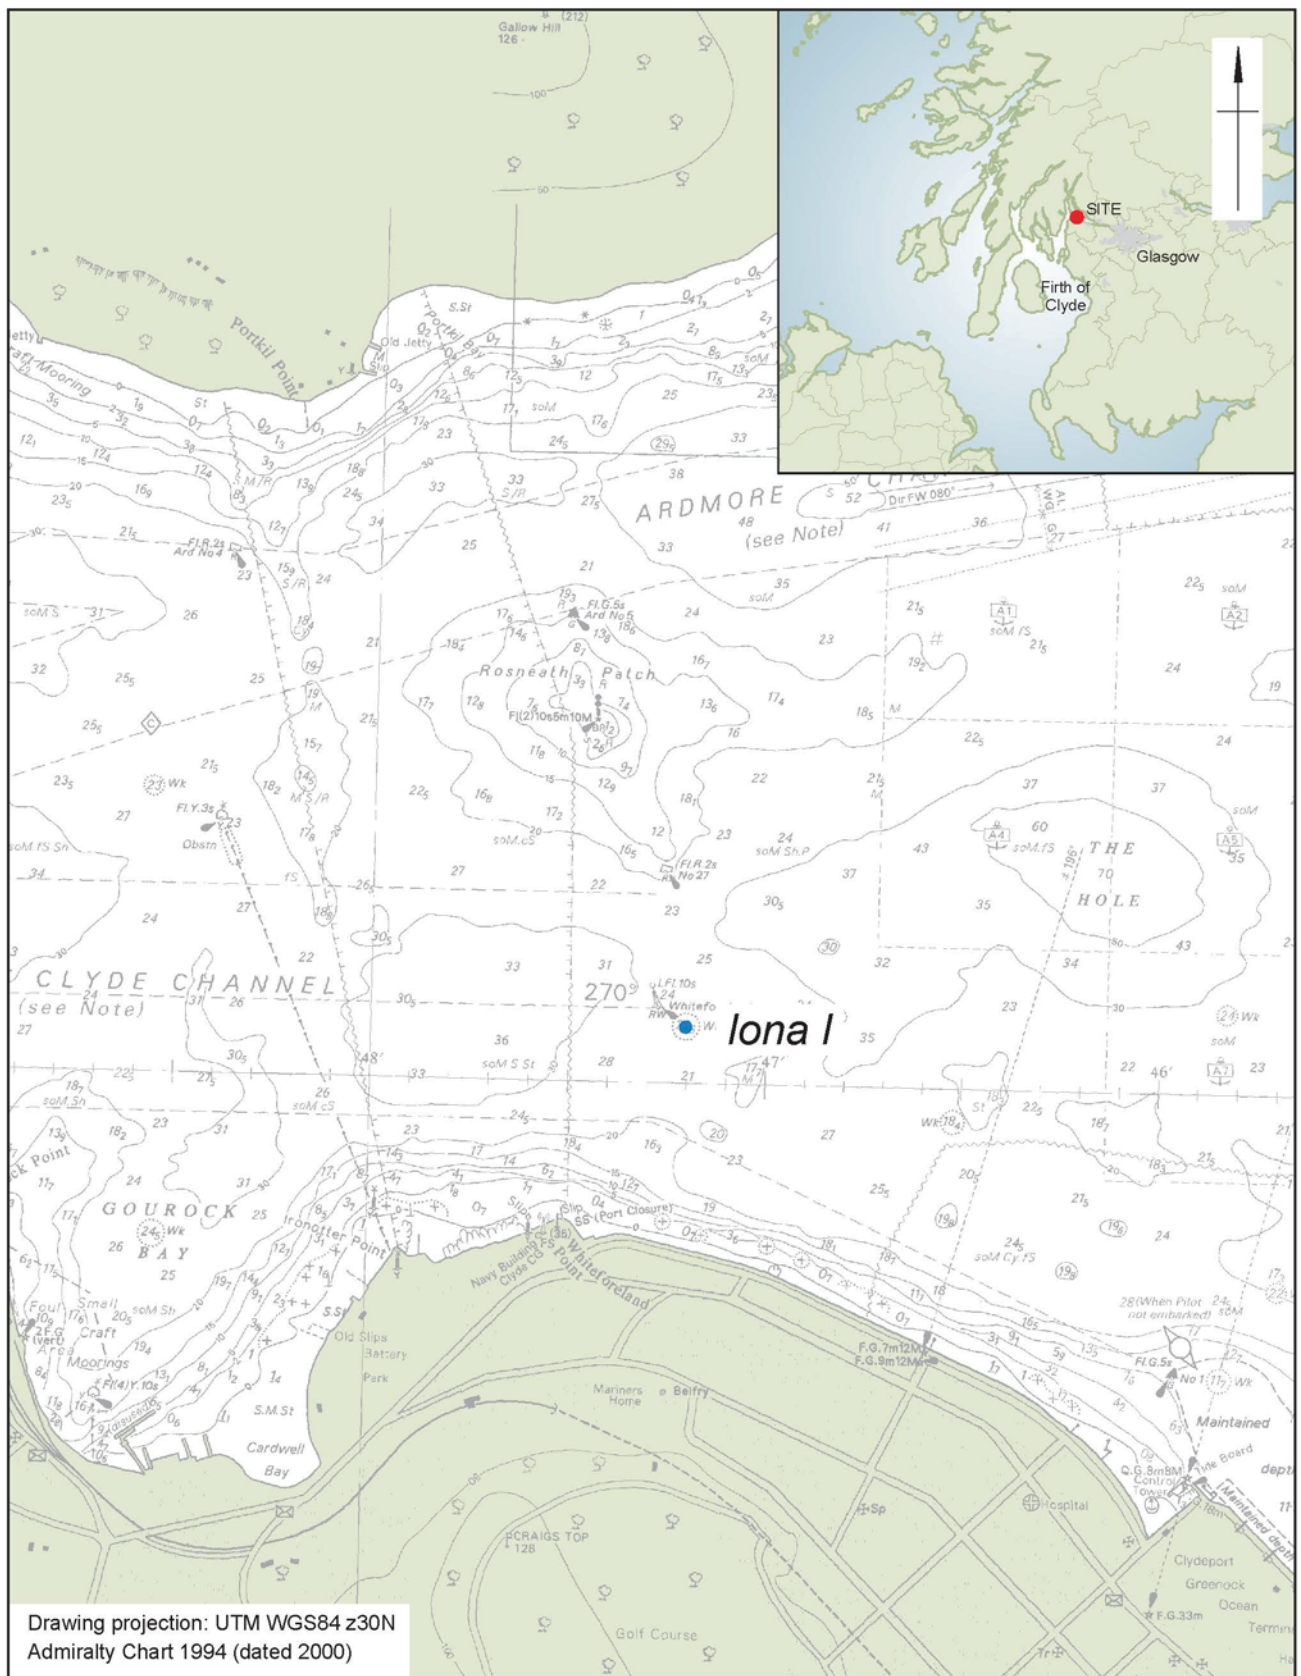
Figure 1

● Geophysics and tracked diver position for funnel base 2013:  
55°58.0780'N 04°47.1998'W  
(WGS84 zone 30N)

- 1.1.2. The assessment was conducted as part of a programme of works undertaken as part of the Contract for Archaeological Services in Relation to the Protection of Wrecks Act (1973) (PWA). The site lies in UK territorial waters off Greenock and Gaurock in the Inner Clyde Estuary (Firth), Scotland (**Figure 1**).

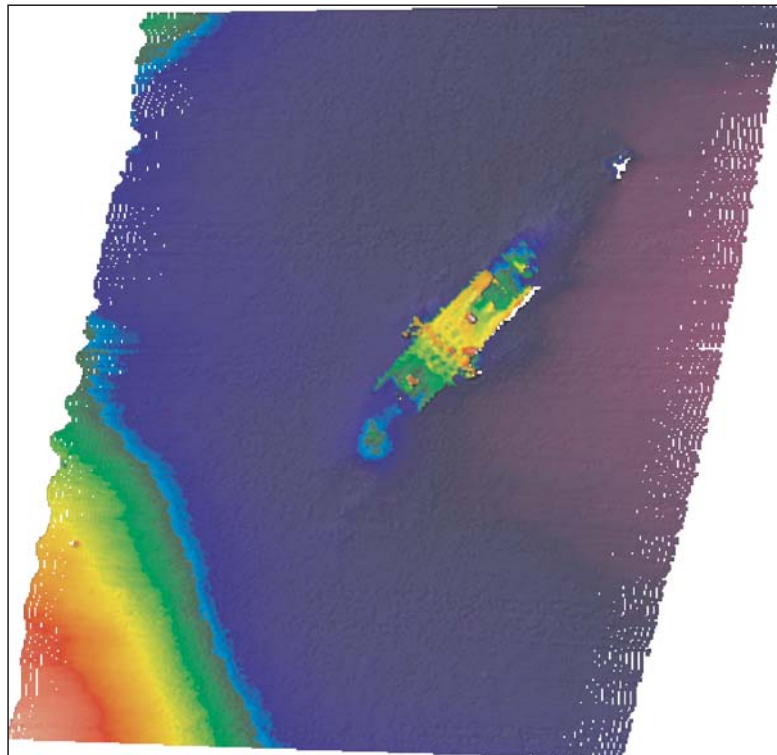
A. Multibeam swath bathymetry of site and vicinity (copyright Clydeport)

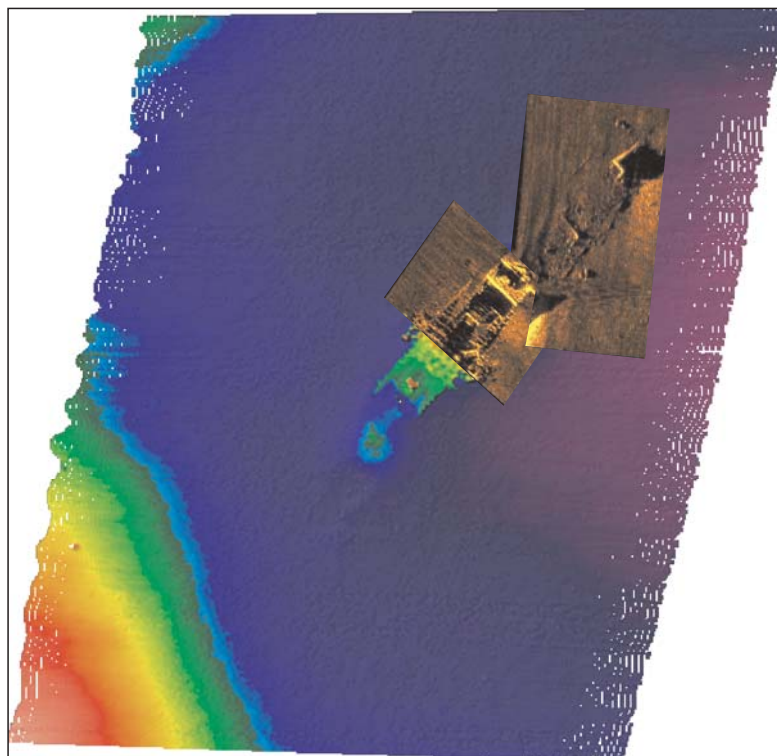
B. Multibeam swath bathymetry of site with sidescan sonar images (copyright Clydeport and OceanMermaid Survey)

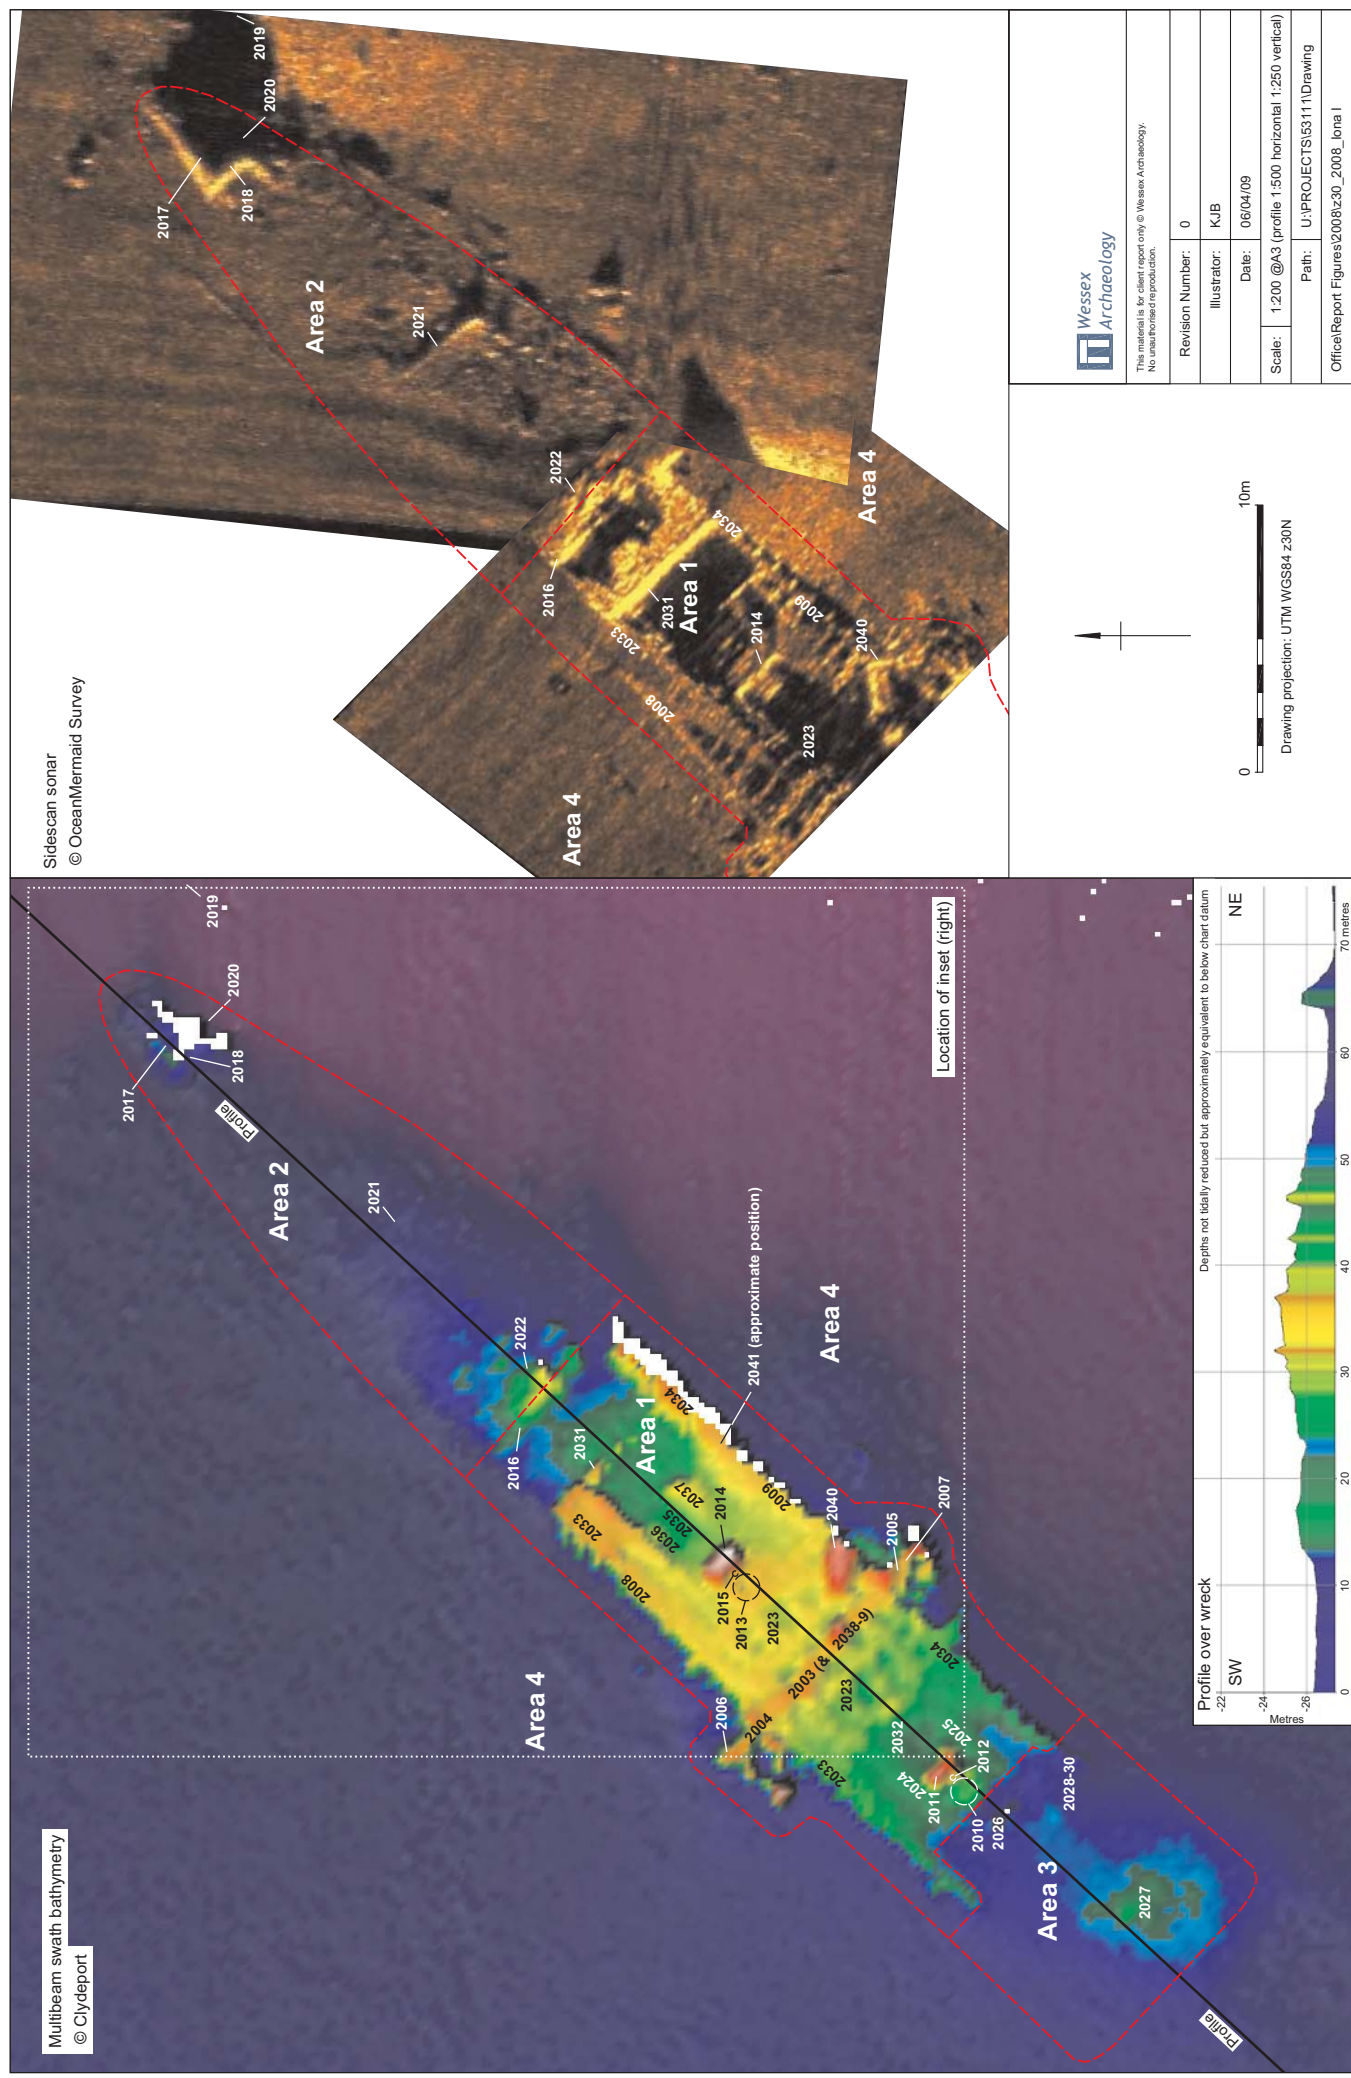
Figure 3

2009 WA site plan

- 5.3.4. Within the central area lies the hull of the vessel, orientated roughly south-west to north-east. One end of the hull appears to be present and exposed at the north-east end. The hull here is upstanding by an estimated 1-2m. Bounded to the south-west by a transverse bulkhead and about 4.5m long, it narrows to a v-shaped point level with the seabed at the north-east extremity. The other end of the vessel is either missing or is buried.

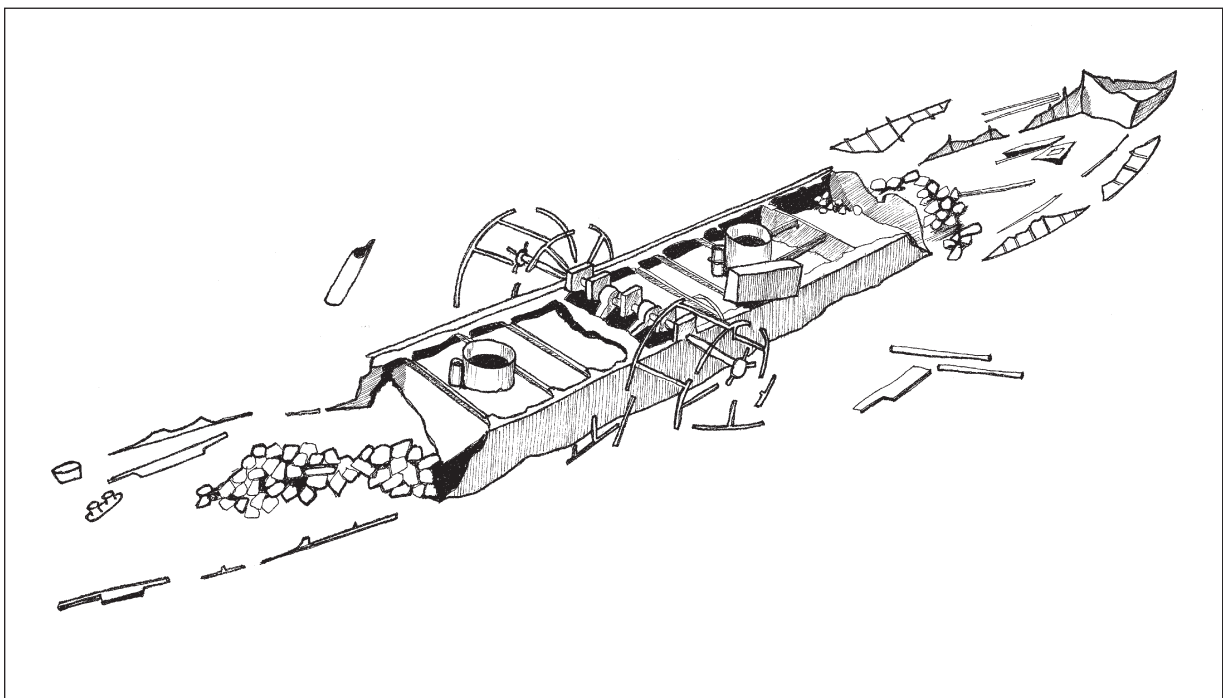
Plate 4: Sketch of site (copyright Peter Moir)

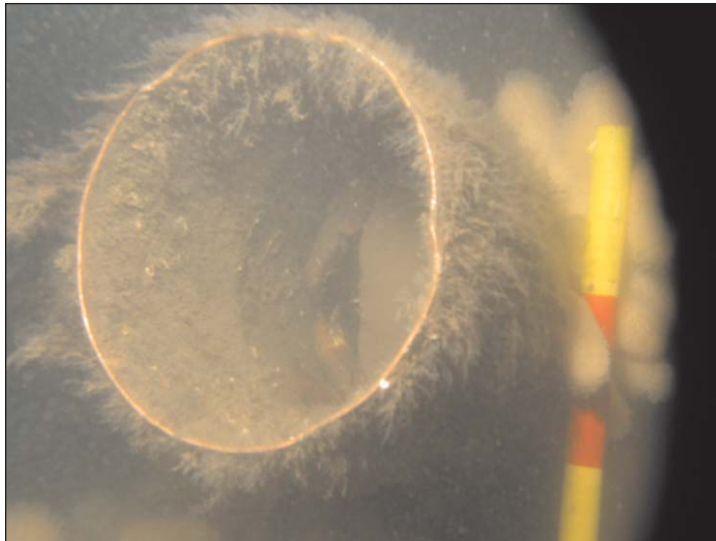
Plate 5: Cuprous pipe 2015 (scale 10cm divisions)

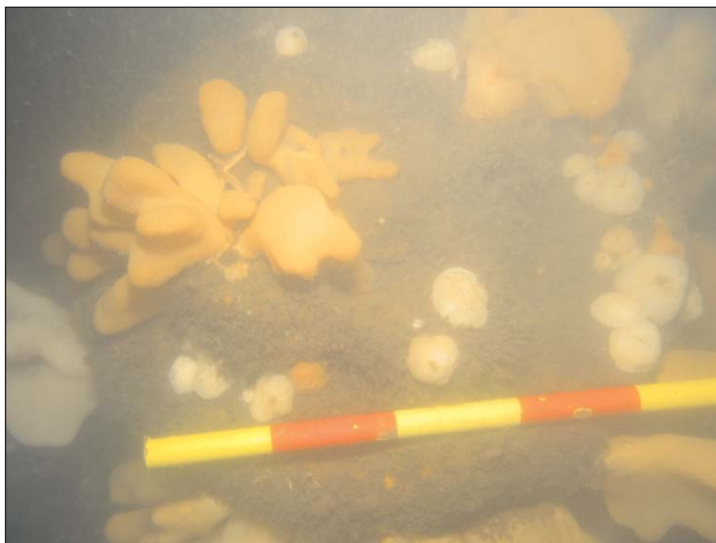
- 5.3.19. To the north-east of the funnel base is an upright ferrous metal object (**2011**; **Plate 6**). Heavily concreted, its exact form could not be established in the time available, although it was noted to be at least partly cylindrical, with a roughly square shaped fitting on its closed upper end. It is upstanding by about 1.75m and was estimated to be at least 0.7m in diameter. The sidescan evidence suggests that it may be attached to the boilers below. Attached to **2010** by a 90 degree bend, at about one-third height on its south-west side, is a thin-walled upright cuprous pipe of 0.2-0.25m diameter (**2012**).

Plate 6: Unidentified iron cylinder 2011 from above (scale 10cm divisions)

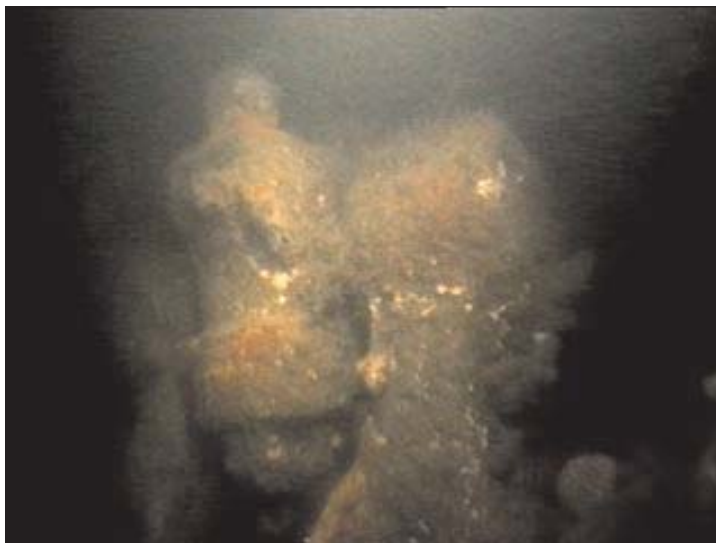
5.3.11. The two crankshafts were not surveyed in detail but appear to be intact and comprise flange couplings, bearing surfaces, crank arms and crank pins. Two vertical piston shafts and couplings (**2038** and **2039**) were observed but no connecting rods. Although the cylinders themselves are buried, this indicates that the engine had two cylinders and was probably of the oscillating type (which dispensed with connecting rods). The machinery is upstanding from the seabed by up to c.1m.

Plate 7: Crankshaft/piston detail (copyright Peter Moir)

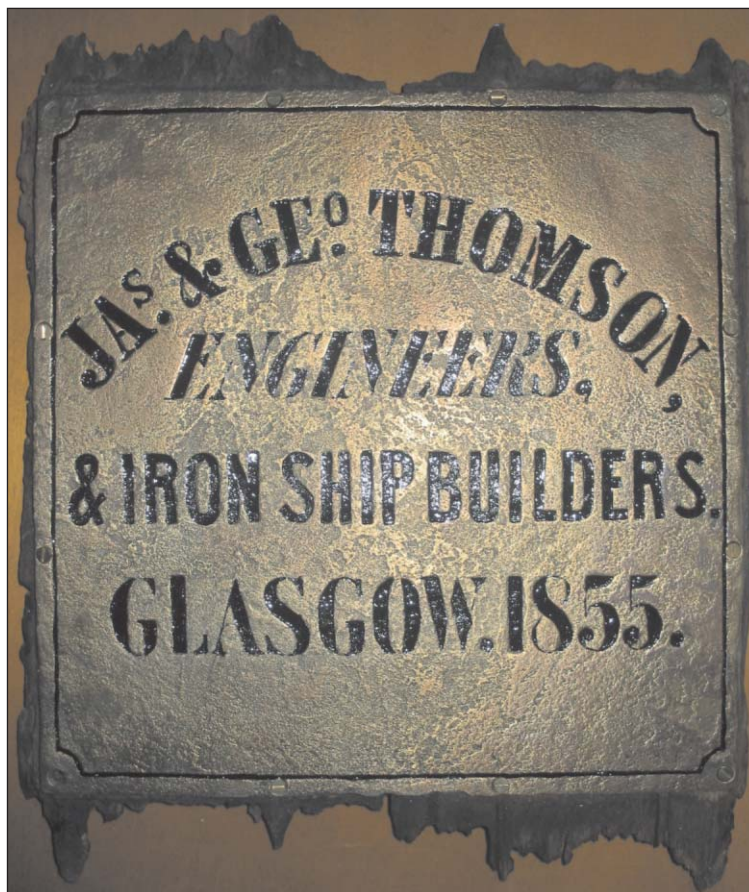
Plate 8: Builders plate found on the site

The site has been subject to some salvage, most recently by avocational divers. A number of artefacts are known to have been recovered and some of these, including a builder's plate, reside in a private collection and have been examined by Wessex Archaeology.

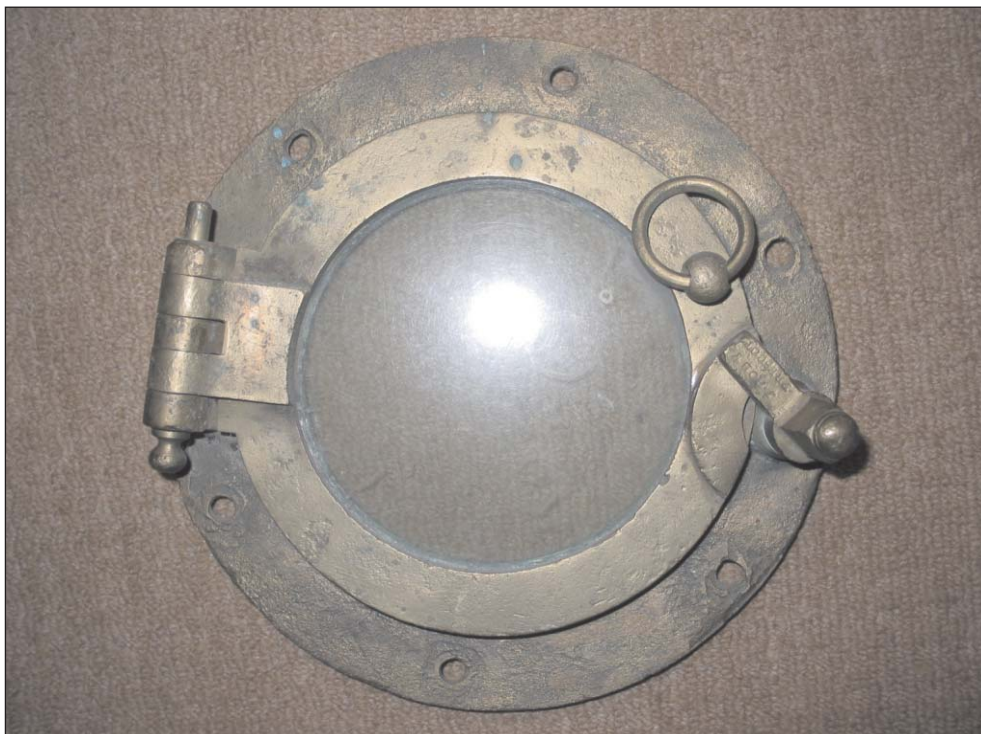
<b>Object No.</b>	<b>Description</b>	<b>WA Photograph No.</b>	<b>Current Location</b>
	circular frame with six bolt or rivet holes for attaching scuttle to hull. No obvious sign of mounting point for a deadlight. Dog inscribed 'J. Roby Prescott(t?)'. Possibly made by John Roby Limited, brass founders specialising in ships' equipment, who operated from a brass foundry in Rainhill, near Liverpool from the late 1850s.		
3006	Decorated glazed ceramic toilet bowl.	Not seen by WA	Unknown
3007	Decorated glazed ceramic toilet bowl.	Not seen by WA	Unknown

Plate 9: Scuttle found on site
