Historic England's First World War Submarine Wreck Project

Approaches to Wreck Investigation - Appendix

Summary

Case study – using BULSI to describe UB-107

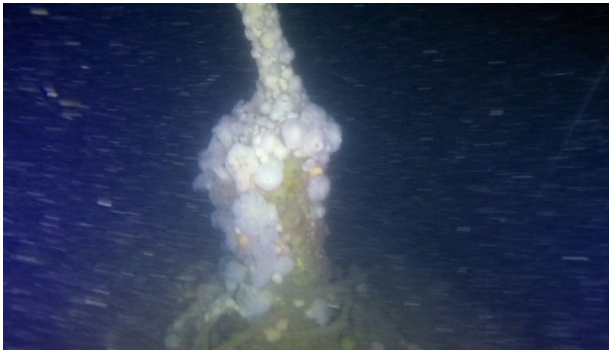
Unidentified fitting
4

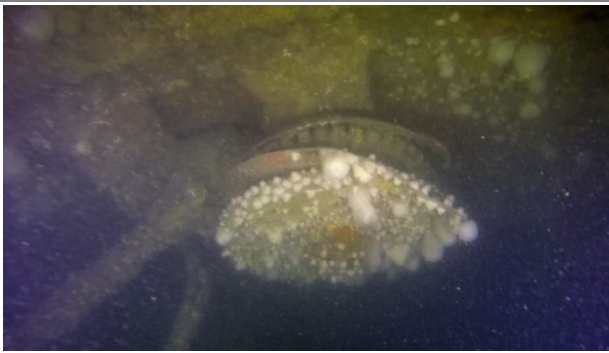
Unidentified fittings within the pressure hull
21c

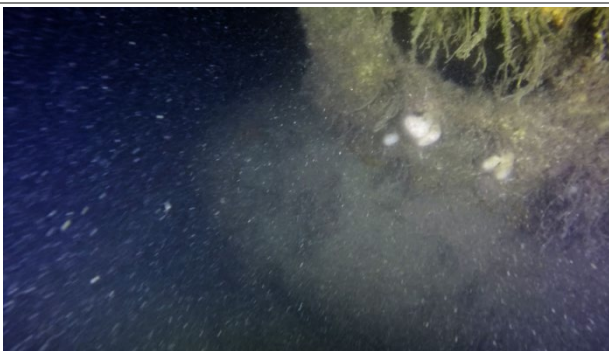
Unidentified fitting on forward deck, possible stanchion slot
26

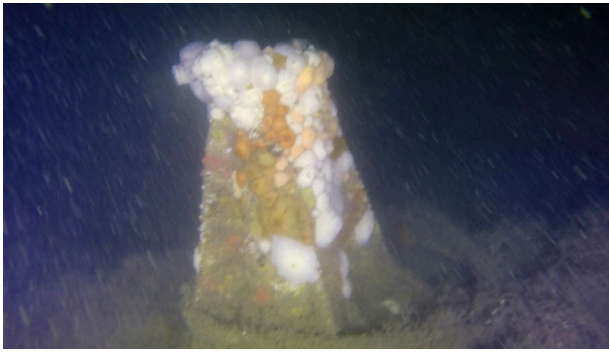
Displaced piping, possible exhaust
30

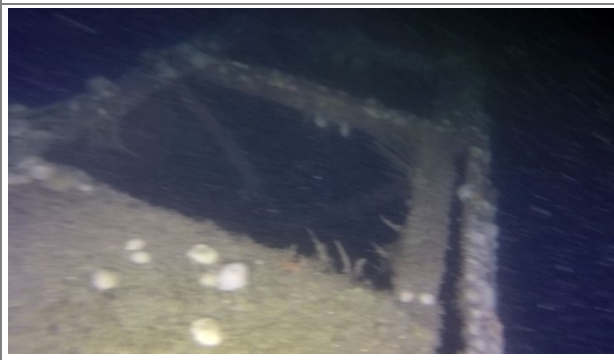
35

Further forward the top of the deck casing is missing, revealing the internal cross struts (12 and 35) and further towards the conning tower some piping can be seen inside two round holes that pierce the pressure hull.

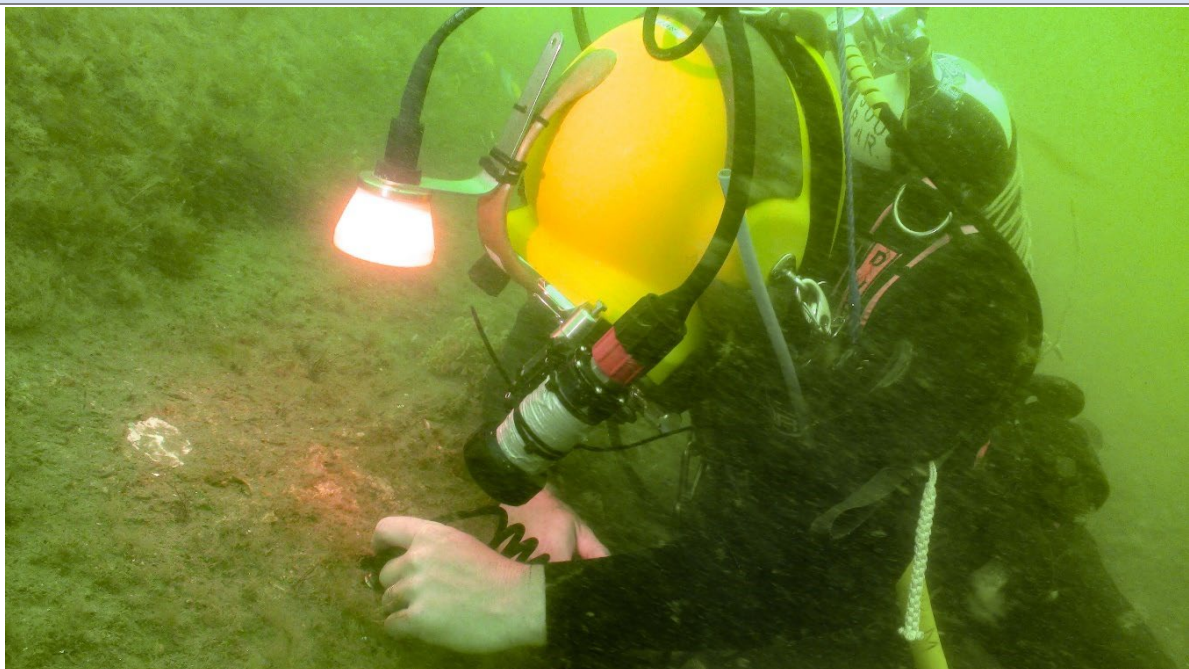
Surface supplied diver taking a UT measurement of the A1 hull through a small hole in the concretion.

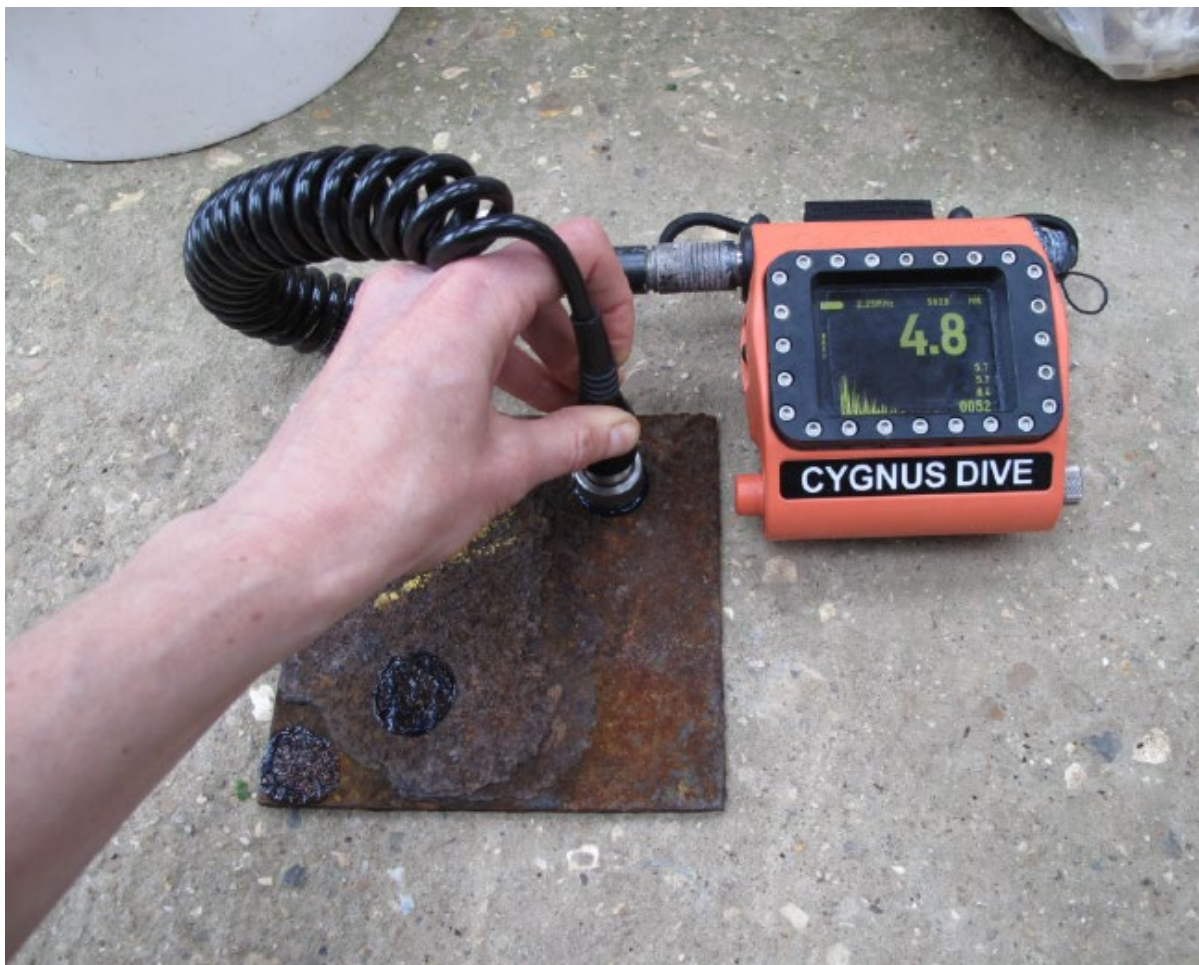
Calibrating the gauge against a test piece. The probe has to be pressed against the surface to make good acoustic contact.
